BOARDMAN RIVER FEASIBILITY STUDY

Preliminary Engineering Evaluation of Existing Structures

January 2008

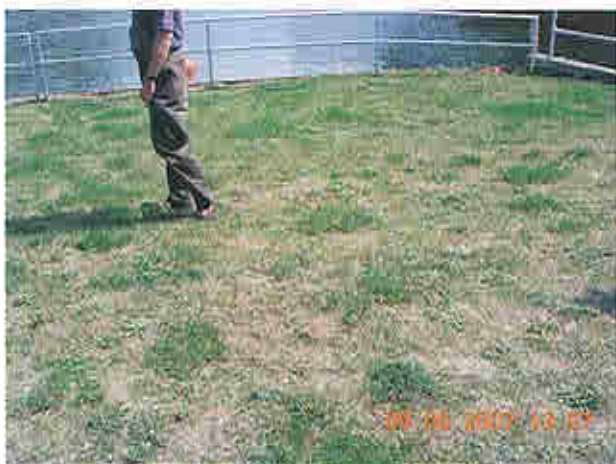
Left end of upstream slope at principal spillway, irregularities
In slope noted

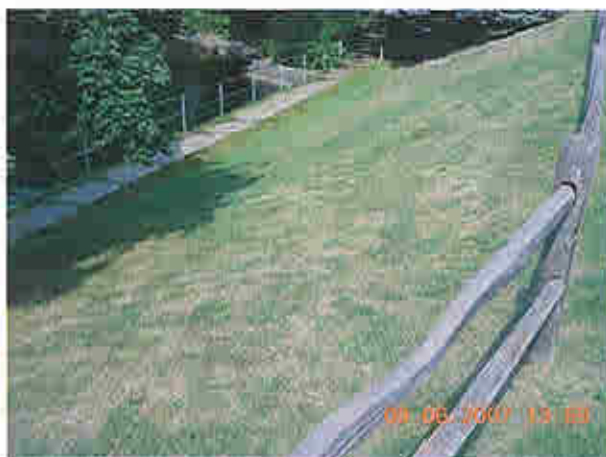
Downstream slope at principal spillway, note irregularities in
slope

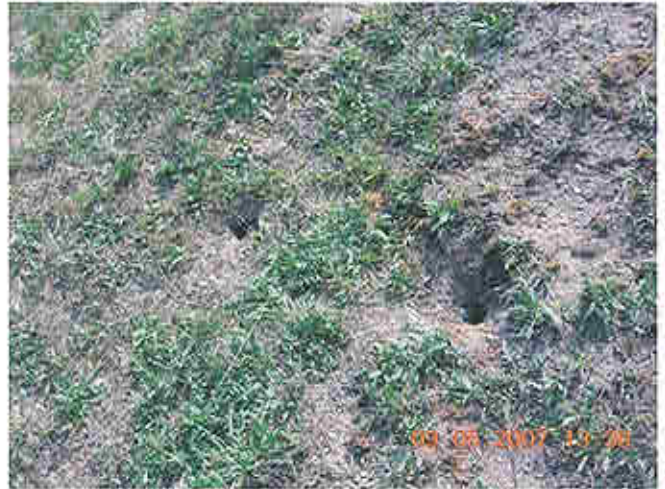
- Rodent holes were observed at the downstream slope of the intermediate embankment.
- At the upstream side of the right end of the right embankment an area of change in vegetation was noted. It is speculated that this area had experienced erosion or a localized failure in the past and since has vegetated and stabilized.

Rodent holes observed at downstream slope of intermediate embankment

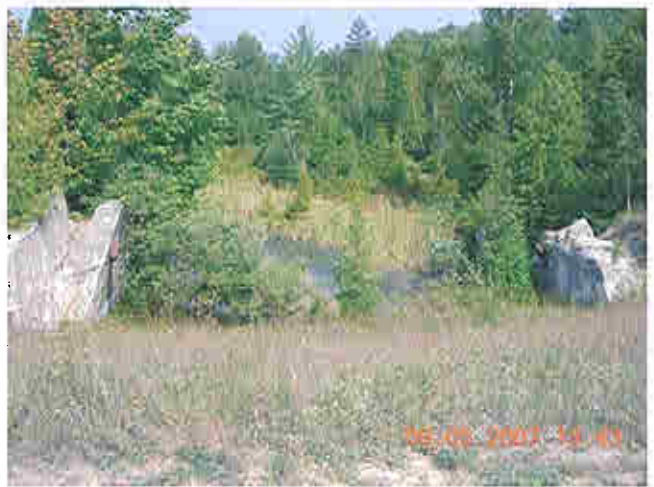
- Corrosion noted on angle brackets at door and window framing.
- Cloudy standing water downstream of the right embankment at the location of the original spillway was observed, as reported in the 2006 FERC Operation Report.

Standing water downstream of right embankment (downstream of original spillway)

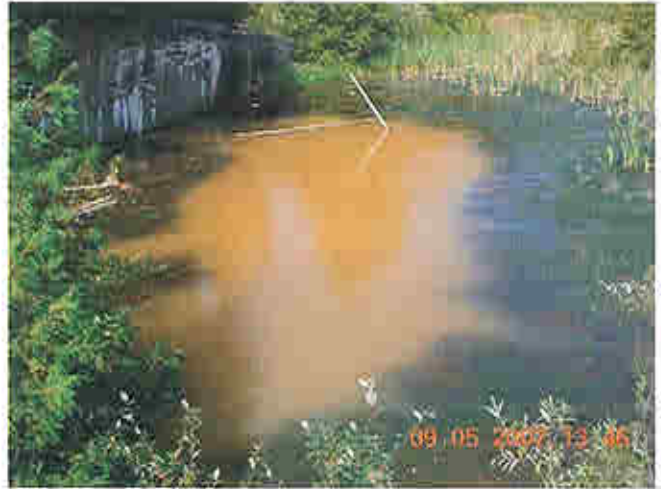
Standing water downstream of right embankment
(downstream of original spillway)

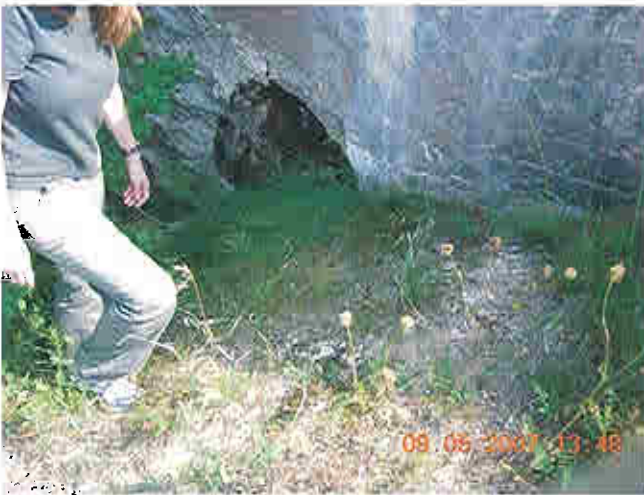
Seep at original spillway structure, right abutment wall

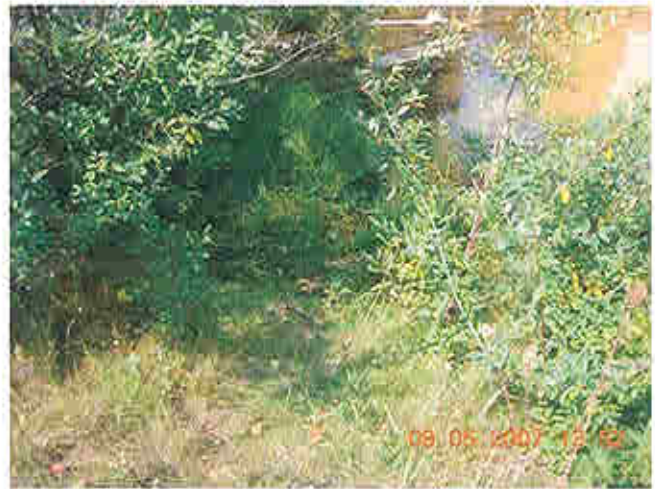
Seep at toe of right embankment, near standing water

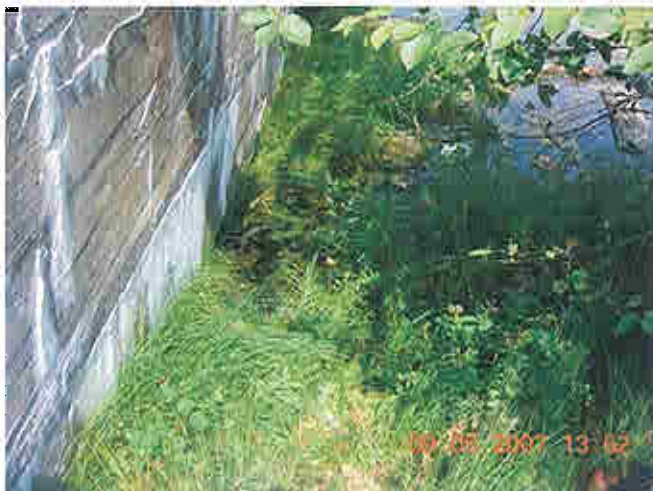
Seep at original spillway structure, left abutment wall

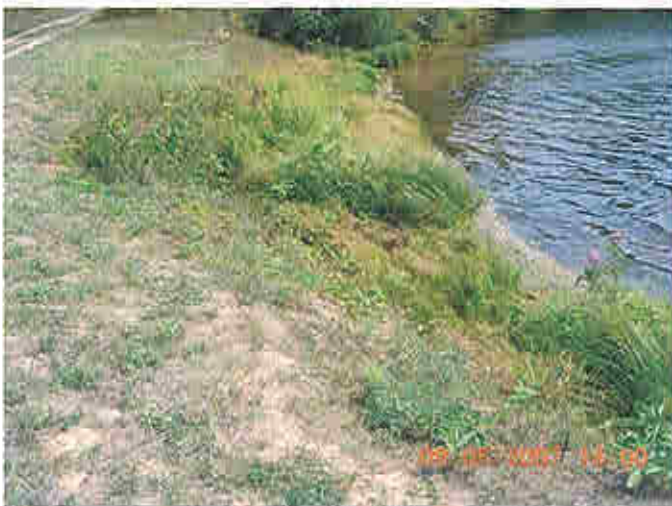
Upstream of right embankment, once eroded but since
stabilized vegetated area

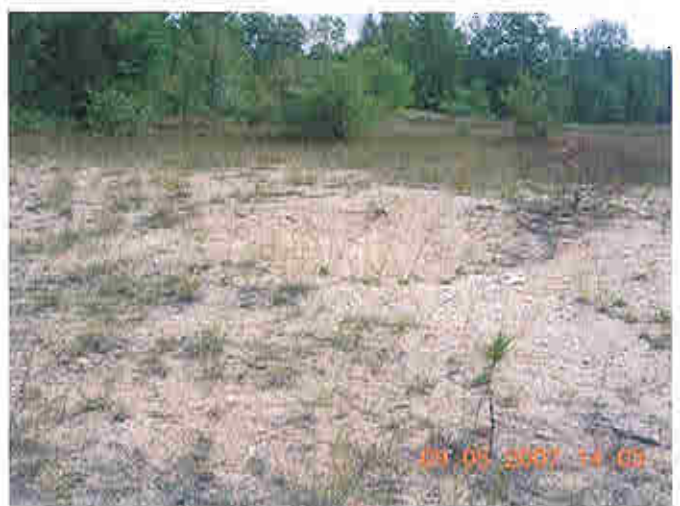
Downstream of right embankment, unvegetated sandy area
with unexplained hole

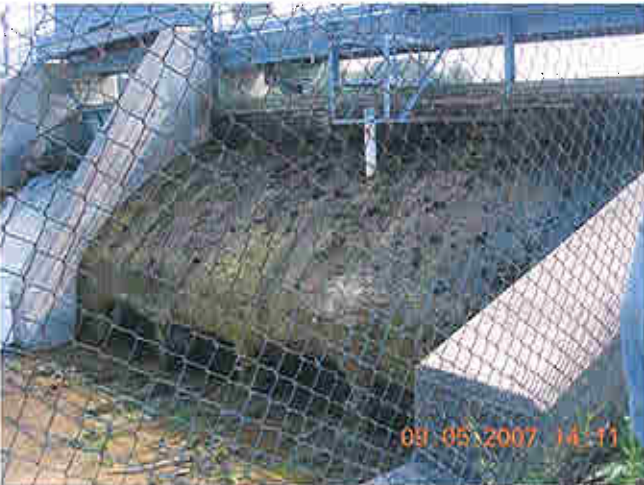
Downstream side of stop log spillway, note spalling/ deterioration

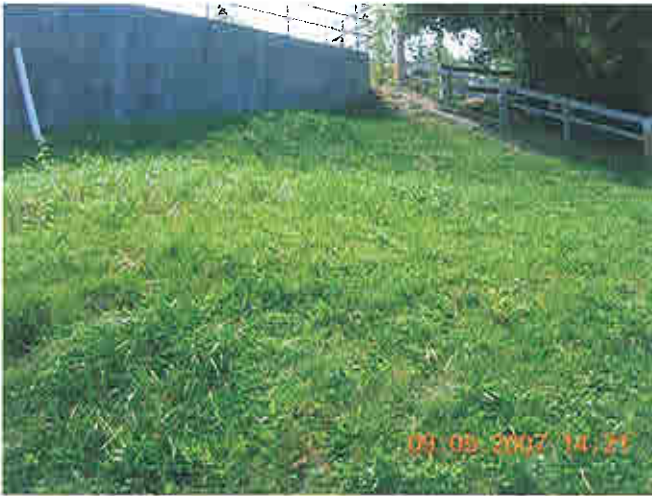
Downstream slope of left embankment, soft moist areas

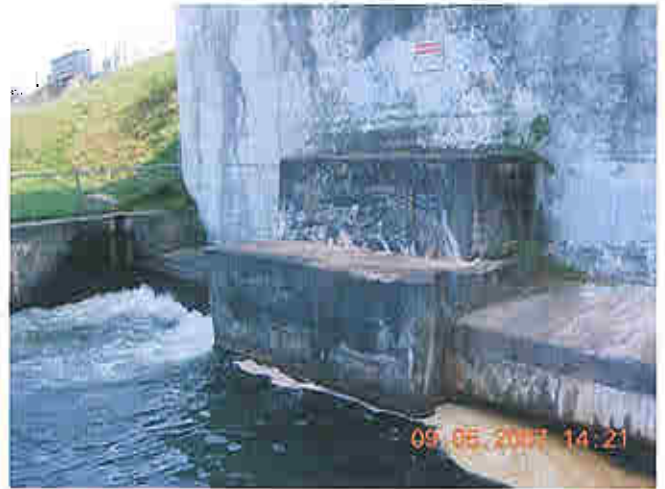
- Concrete deterioration and spalling were noted on the downstream side of the powerhouse, as reported in the 2006 FERC Operation Report. It should be noted here that such spalling, will continue to increase with each winter season.

Downstream side of powerhouse, view from left embankment, note spalling/ deterioration

No issues were observed that would result in major rehabilitation for the project in the immediate future. However, routine operation and maintenance, including roof, brick and concrete maintenance to prevent further deterioration of the powerhouse and dam structure would be required. Additionally, we recommend that when the power generation equipment is removed the flow of water through the dam be assessed. It may be necessary to make both shafts available for water flow. An alternative flow path may include closing off both shafts and routing all water through the spillway.

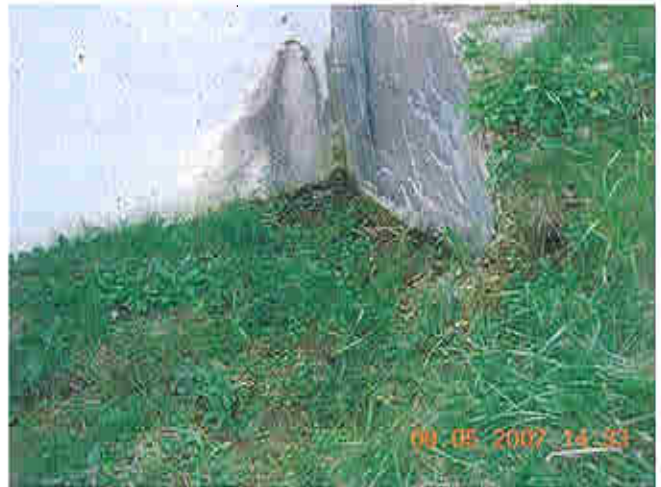
Seep at powerhouse at left embankment

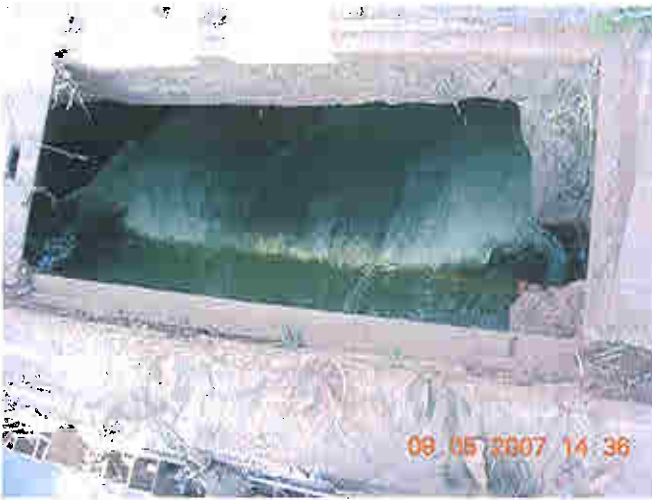
View looking down at stop logs at power house spillway, concrete deterioration noted.

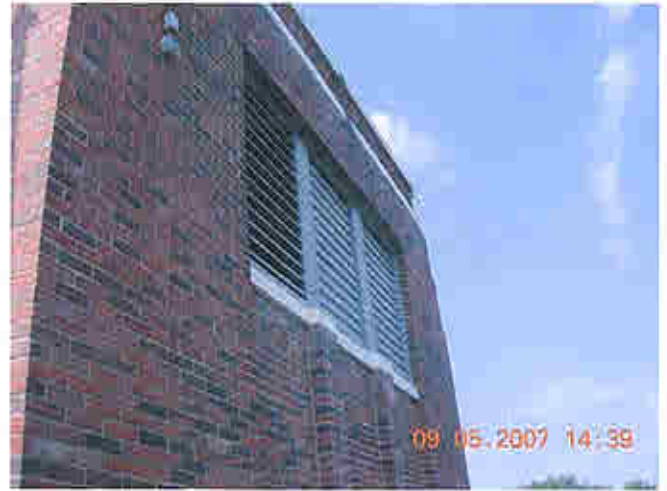
- Deterioration of brick mortar joints and window lintels noted in many locations of the superstructure, along with minor cracks as reported in the 2006 FERC Operation Report.

Right side of power house, note corrosion of window framing
Failing brick work noted

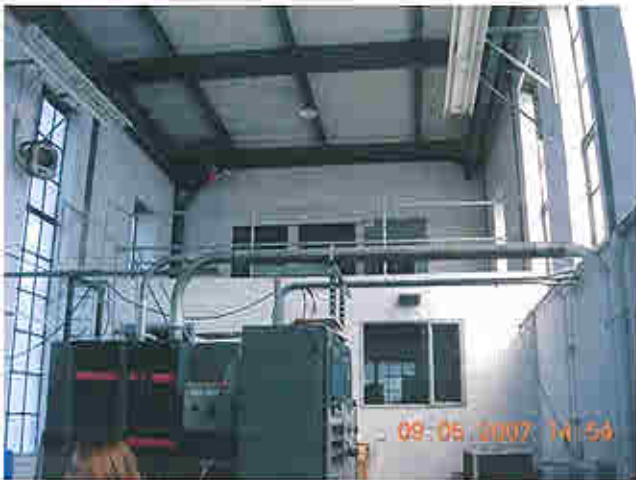
- The roof has been known to leak, per the Traverse City Light and Power Company. Leaking was evidenced by retrofitted gutters on the inside of the building near the downspouts.

Interior of power house, note make-shift roof leak collection

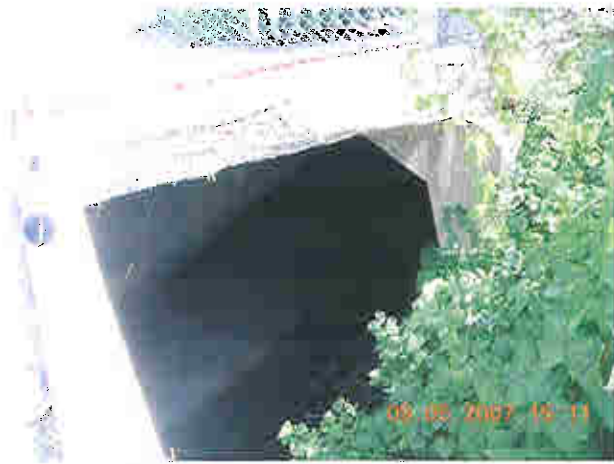
Access deck to the left of the powerhouse, note deterioration

Additionally under this alternative, routine operation and maintenance would be required. Also, the structural integrity of the concrete access deck and Cass River Road Bridge support system would need to be evaluated, and possibly repaired.

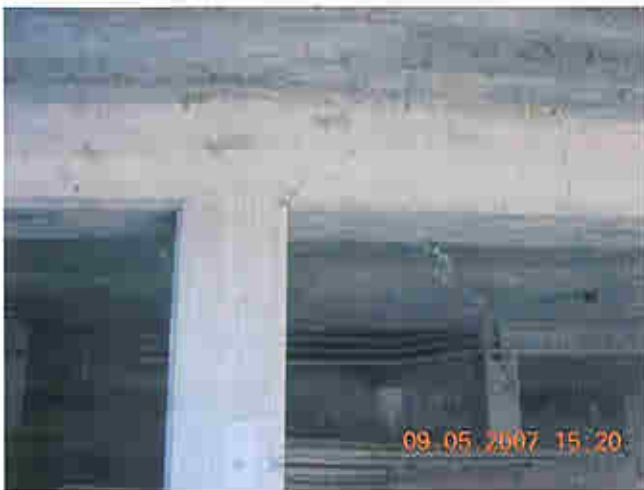
- Cracking of the deck supports and beams were observed. There was also significant spalling and exposed rebar underneath parking deck.
- Roadway guard rails are in disrepair

Underneath of access deck, note cracking and deterioration

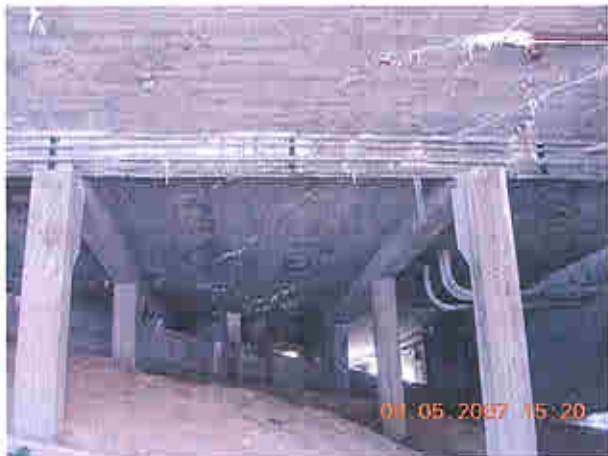
Underneath access deck, note cracking and deterioration

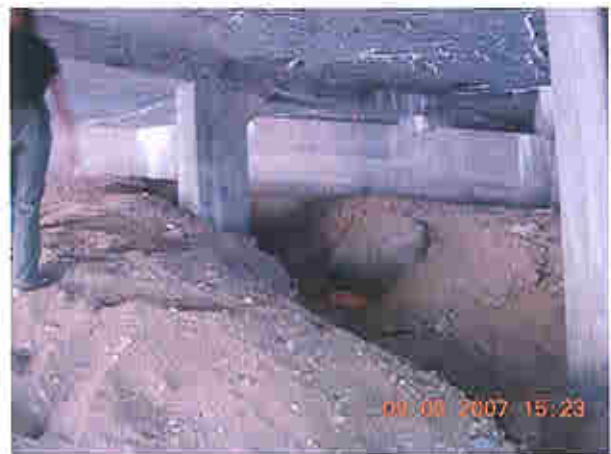
Underneath access deck, note cracking and deterioration

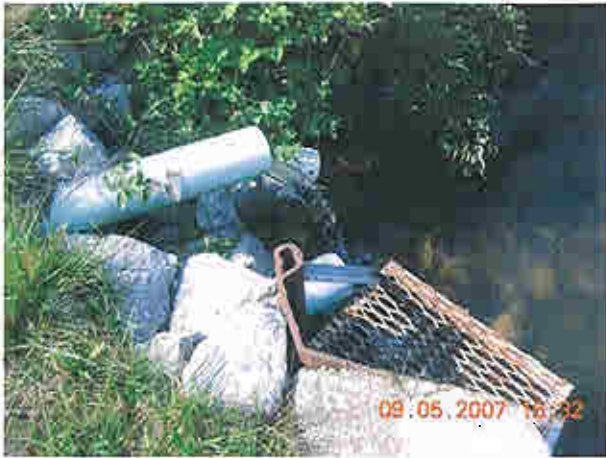
Downstream left of powerhouse, note water flowing

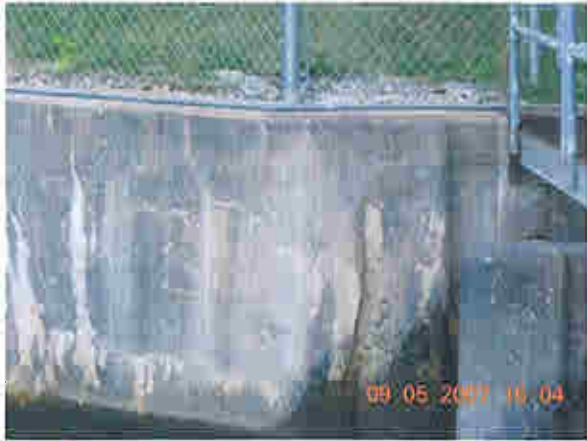
Right side downstream of spillway, note cracking

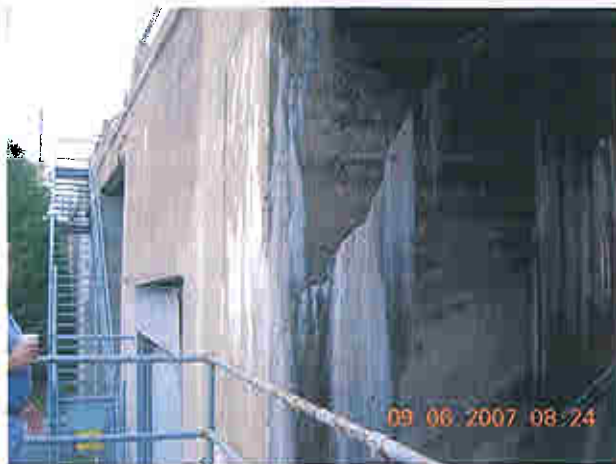
Right wall at spillway, note cracks

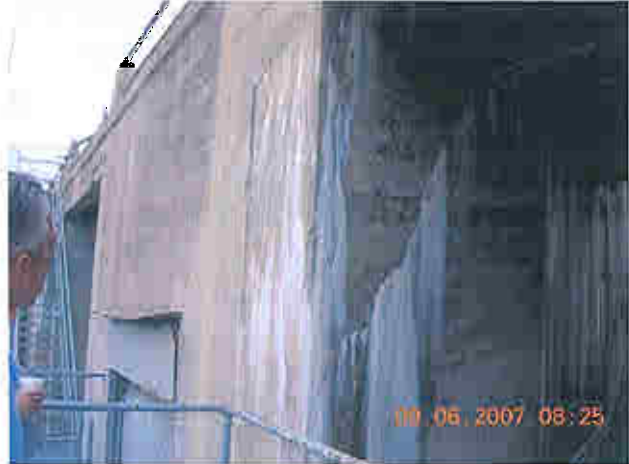
Right wall at spillway, note cracks

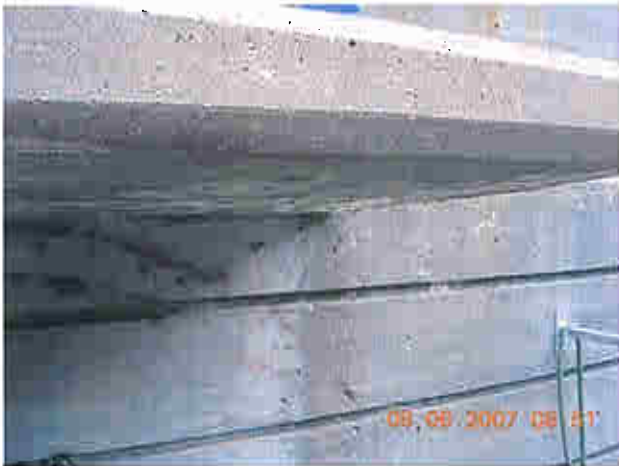
Under deck at entrance to powerhouse, appearance of recent concrete repairs

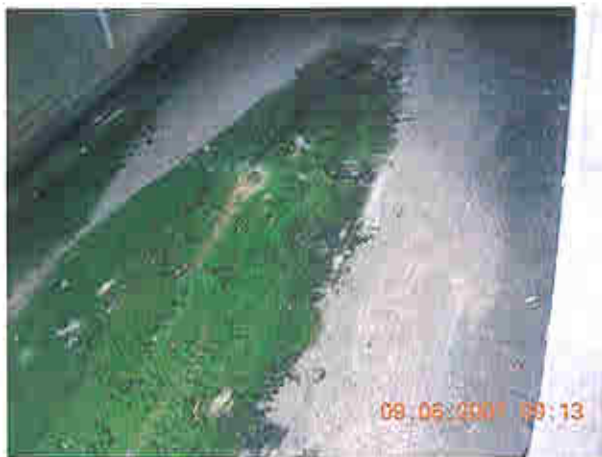
- Structural cracking of Cass River Bridge supports.
- Posted load limitations for Cass River Road of 10-20 tons (depending on no. of axles)
- Downstream "chute" at spillway, seepage is visible at bottom of channel. 1930s construction plans show 4" drain tile located underneath slab. Could be a break in the pipe.

Downstream of spillway, note seepage

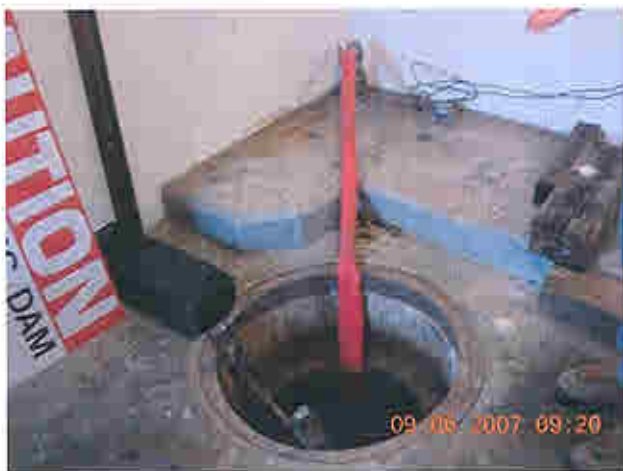
Lower level of powerhouse, location of "leak" earlier this year

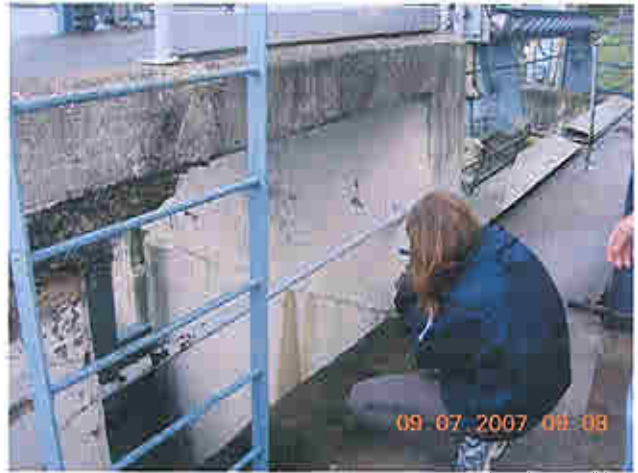
Support at tainter gate, note cracking and degradation

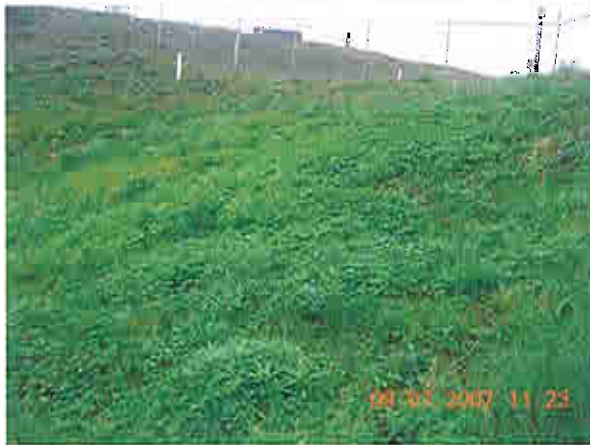
Downstream slope of left embankment, note vegetation, irregular ground surface noted, some soft areas

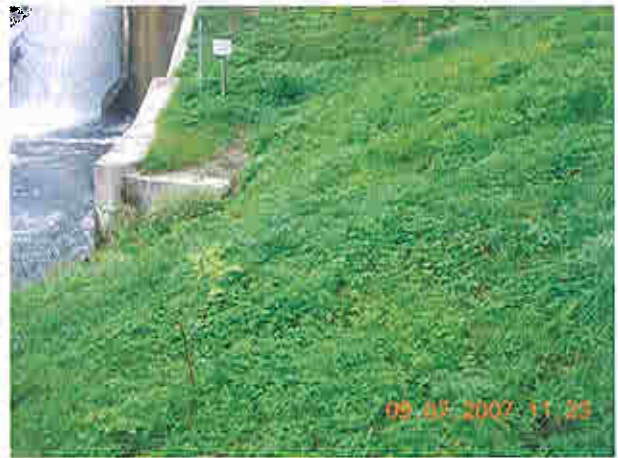
Downstream slope of left embankment, note vegetation, irregular ground surface noted, some soft areas

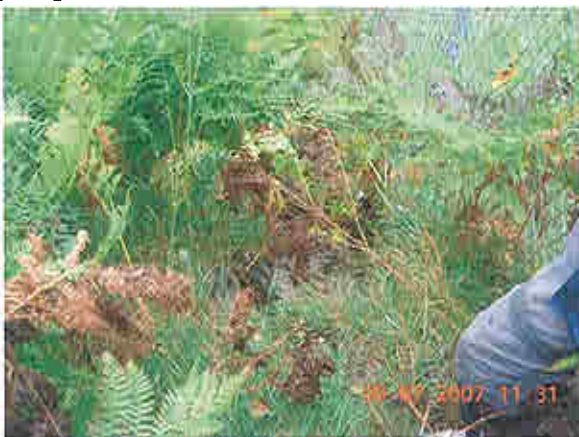
Downstream slope of left embankment, note heavy vegetation, erosion noted along fenceline

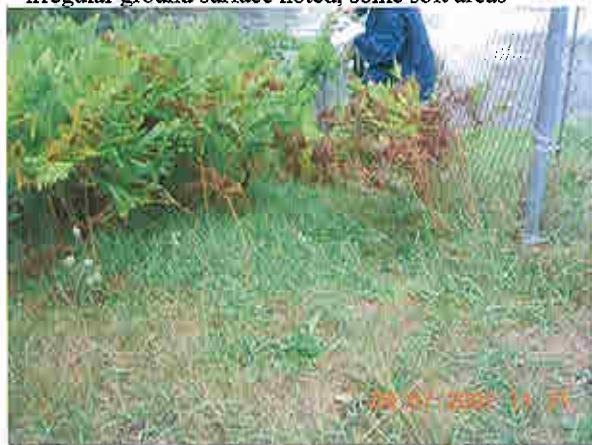
Downstream slope of left embankment, note heavy vegetation, erosion noted along fenceline
