Appendix C

Photographs (29)

Brown Bridge Dam

STS Project No. 200802039

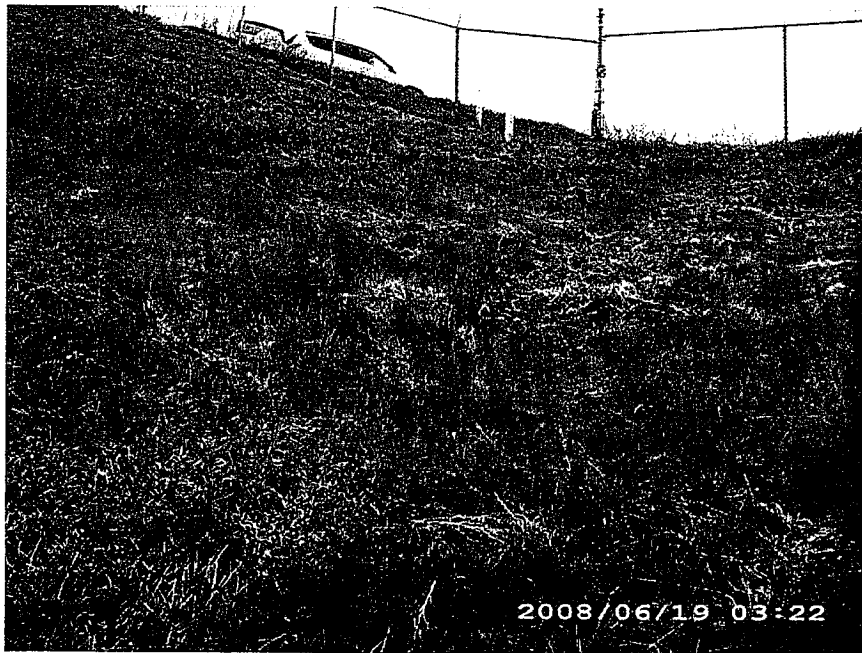
Photo 2 – 6-19-08 – View looking up left embankment from downstream edge of spillway. Seepage water is evident on the groundwater surface in this area.

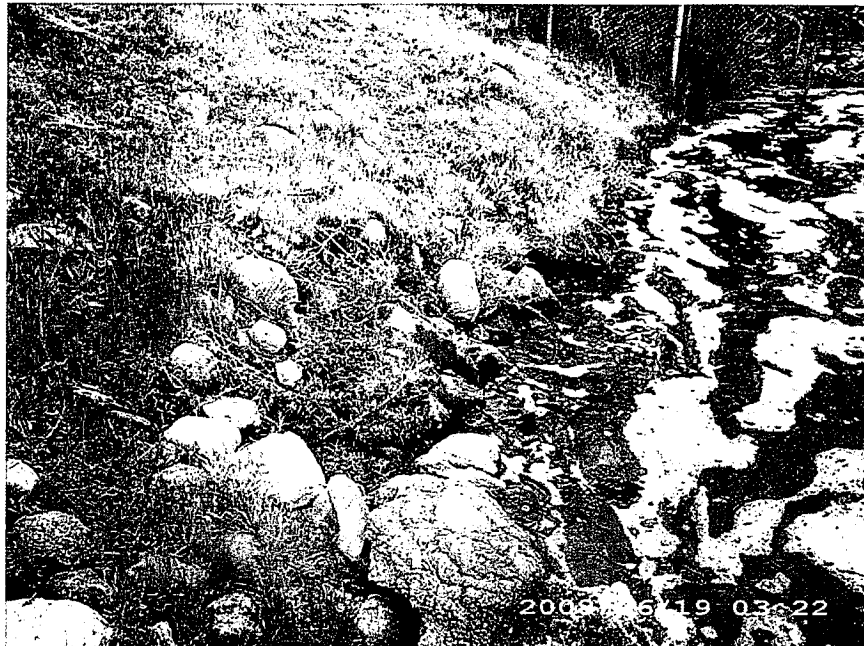
Photo 3 – 6-19-08 – Toe of natural soil to left embankment contact near end of spillway. Note soil erosion at toe of slope. Seepage flow was evident in this area and above.

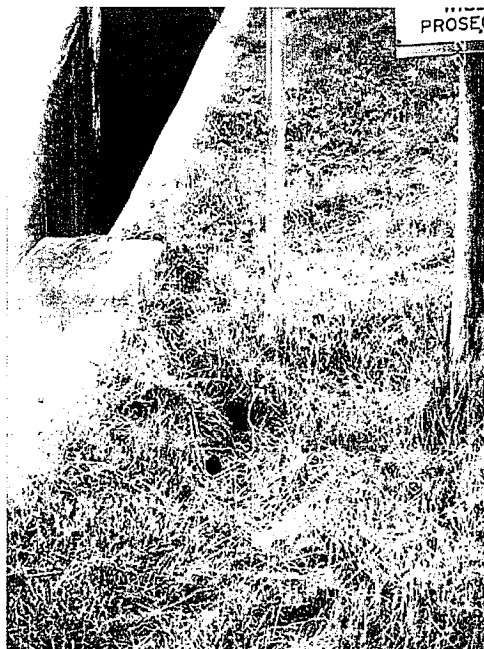
Photo 4 – 6-19-08 – Close-up of seepage breakout near left downstream wingwall of the spillway.

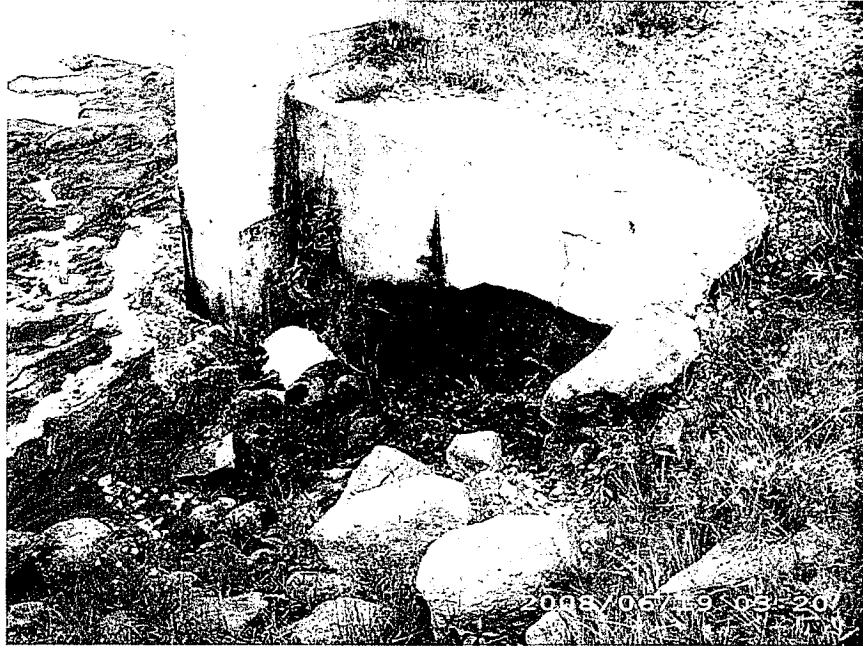
Photo 5 – 6-19-08 – Erosion at contact of left spillway training wall and left embankment toe.
Note seepage from below wall.

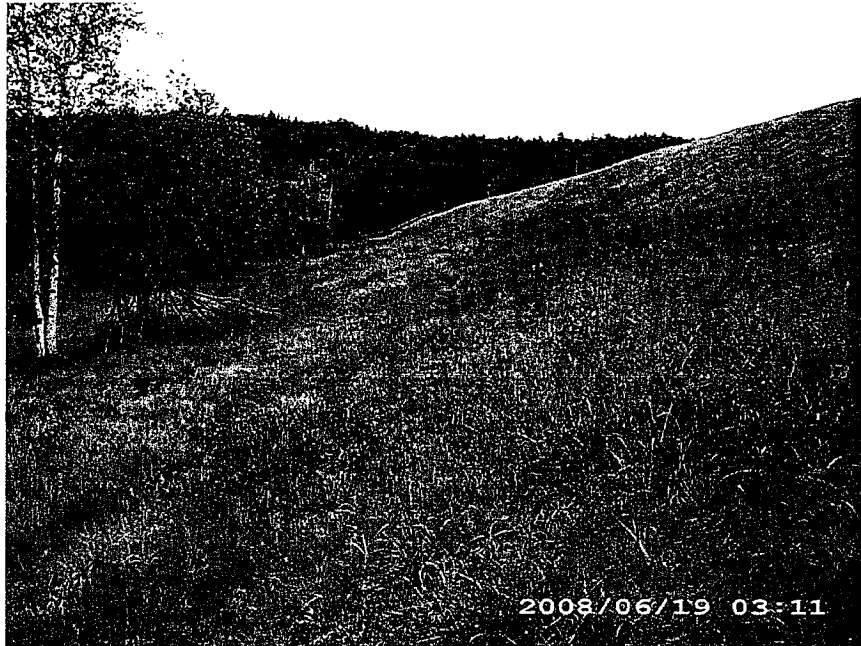
Photo 7 – 6-19-08 – View looking right from spillway. Note that dark green grass identifies elevation where the phreatic surface is close or at the ground surface.

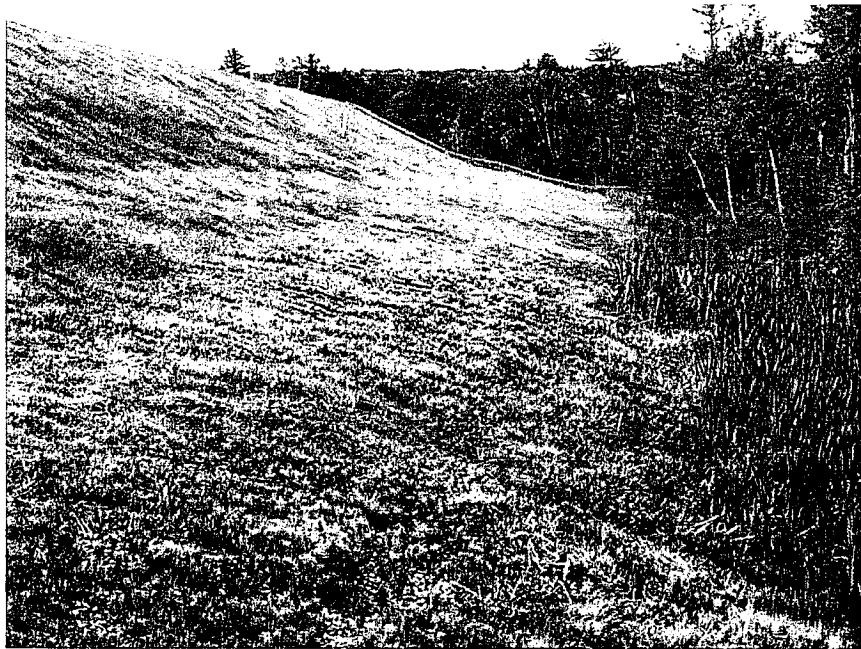
Photo 8 – 6-19-08 – View looking left from toe of right embankment. Note that dark green grass identifies elevation where the phreatic surface is close or at the ground surface.

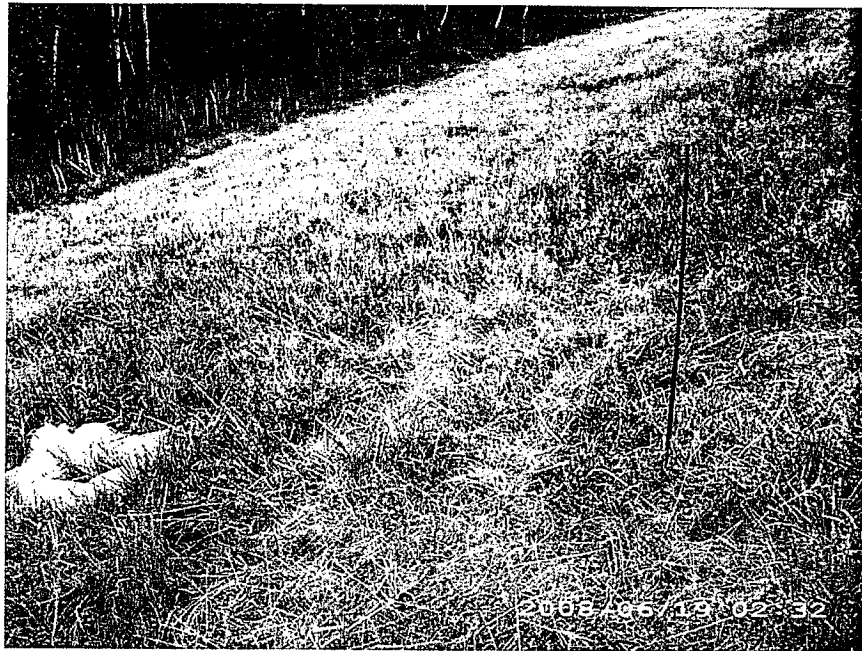
Photo 9 – 6-19-08 – View of rebar probe and area where sand bags were used to confine a former seep. The seep was not flowing but wet.

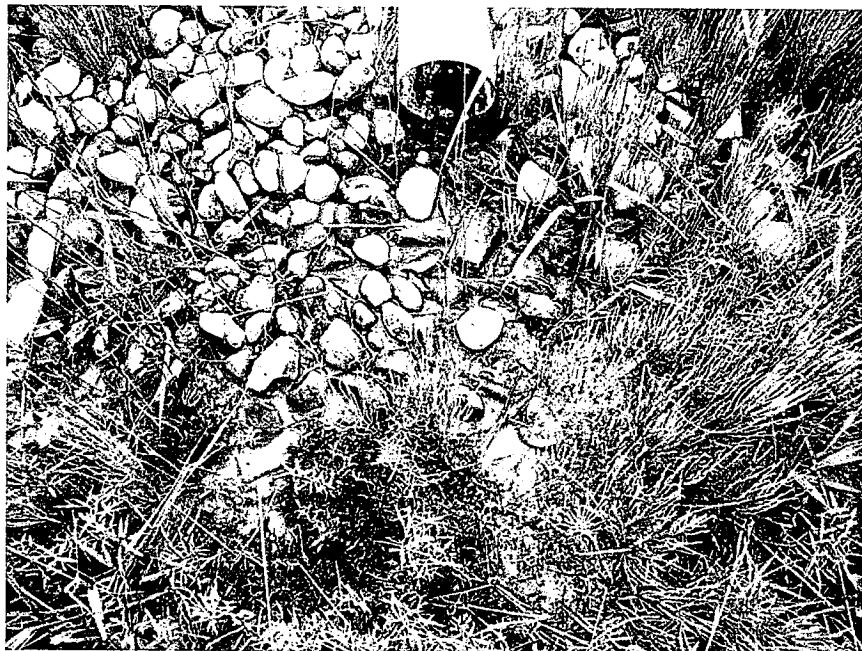
Photo 10 – 6-19-08 – View of typical drain pipe along toe of right embankment. Note sand deposits within grass.

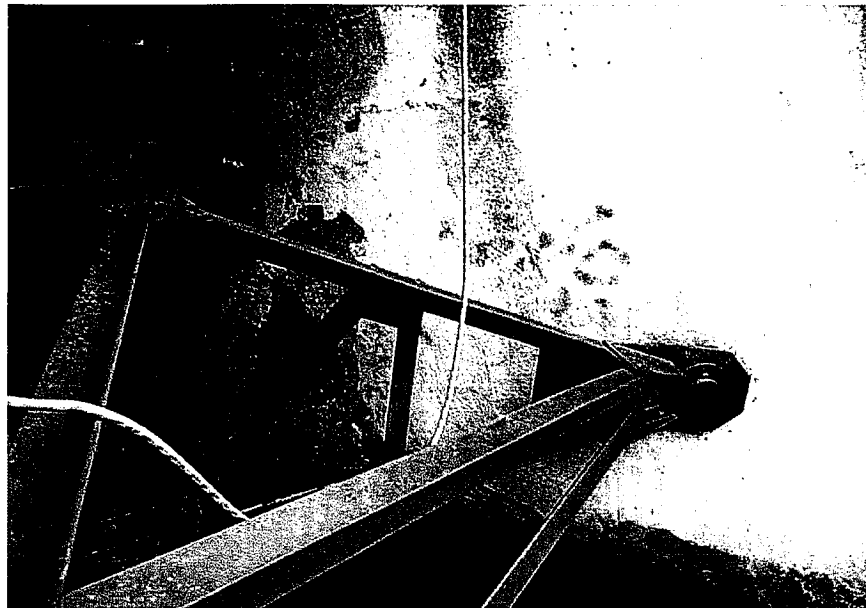
Photo 19 – 6-19-08 – View of downstream side of left gate showing typical concrete deterioration near side seals.

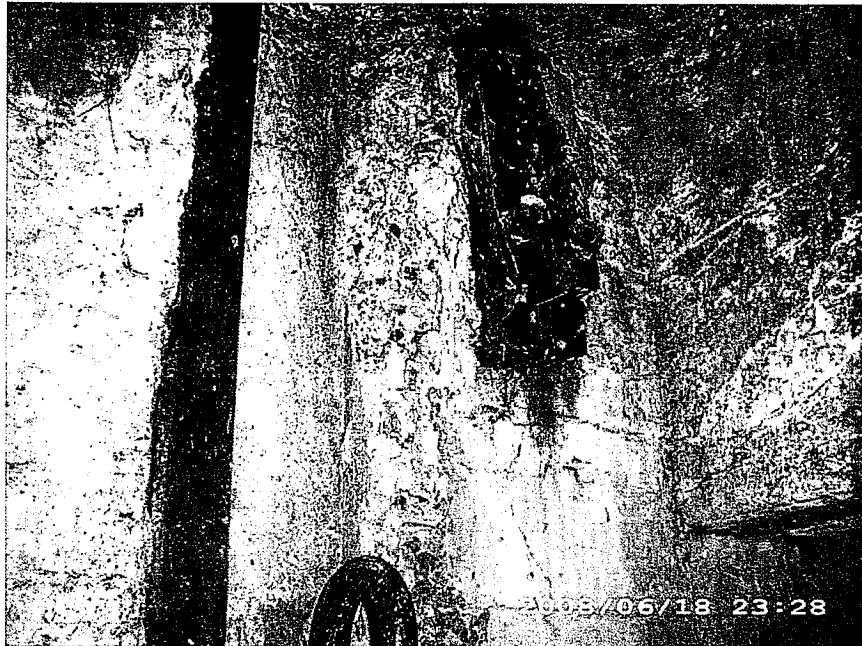
Photo 23 – 6-18-08 – Typical concrete deterioration on upstream side of head gate slot.

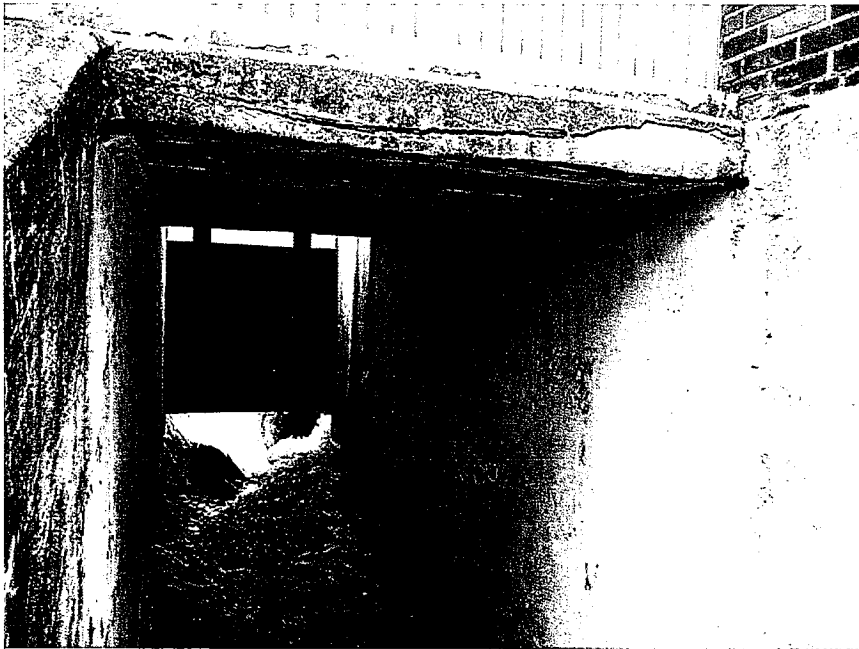
Photo 26 – 6-19-08 – View of log chute and sluice gate. Note deteriorated concrete slab.

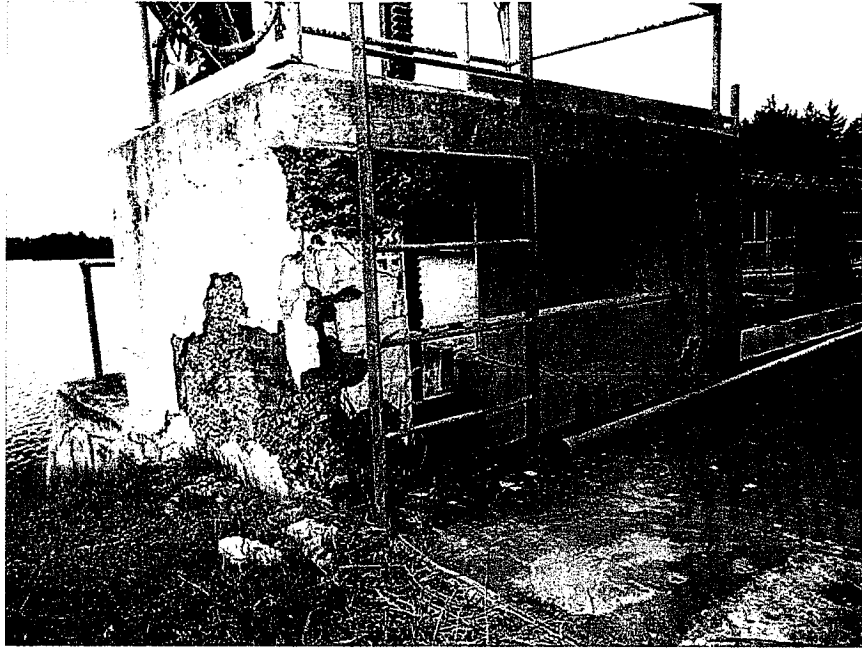
Photo 27 – 6-19-08 – Deteriorated concrete support for log chute gate hoist.
