Clam Lake Shoreline Survey Greenbelt Report

Friends of Clam Lake
And
Three Lakes Association

January 25, 2009

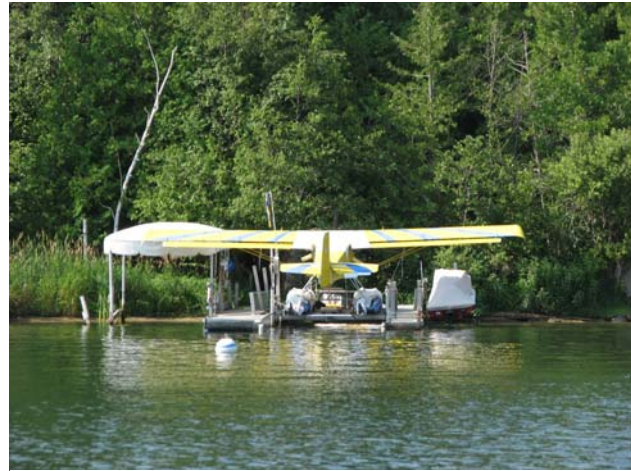
Figure 3 - Sample Shoreline Photo

Photographs were also taken from the

water at the same time the survey observation were made. (Figure 3) The shoreline observations were from the high water mark back 25 feet. Thus, no data was taken on the number of boats, docks, rafts, and etc.

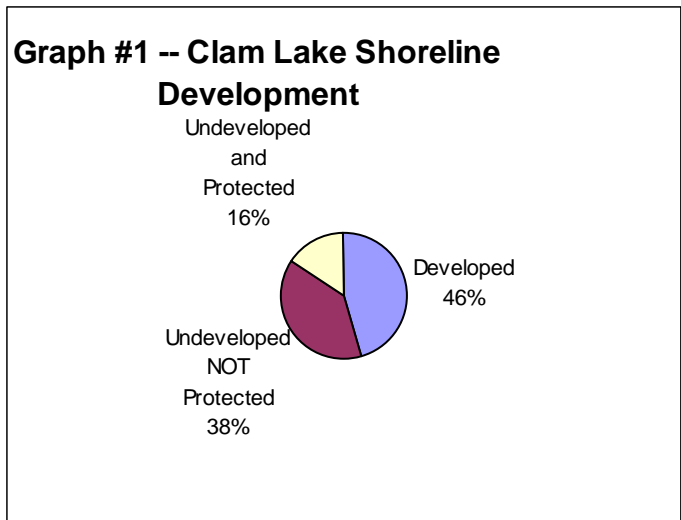
Table 1 and Graph 1; show the level of development of the Clam Lake and Clam River shorelines. As used in this report, the term 'developed' refers to any man made structure between the high water mark and back 25 feet. This could just be a walkway. Protected refers to the property being government owner and assumed to stay that way. The Grass River Natural Area is in this classification. Other parcels that are not developed many also be protected by easement but this data was not readily available.

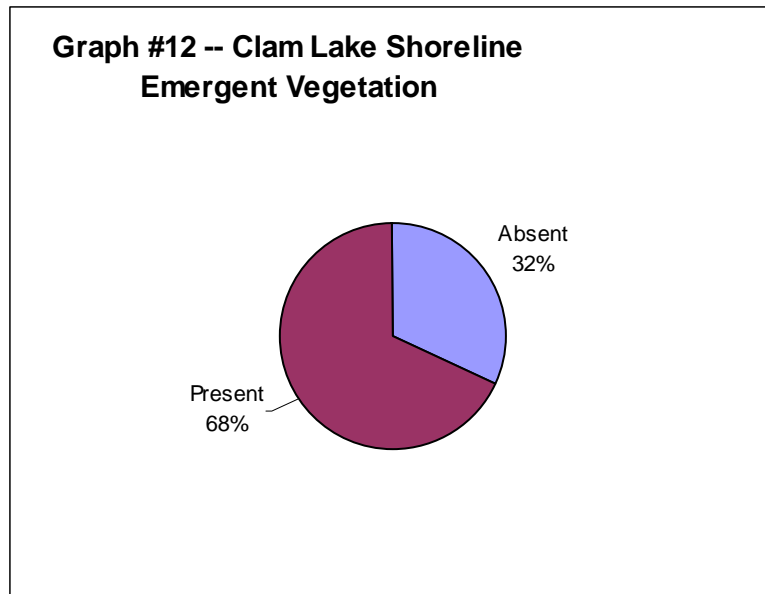
Table 12 and Graph 12; show what percentage of the shoreline having emergent vegetation, which is lake bottom plant growth that reaches the surface along the shoreline.
