BOARDMAN RIVER FEASIBILITY STUDY
A Report on the Boardman River Fisheries Habitat
Survey & Data Collection
DRAFT

January 2008

This report, is an integral part of the engineering feasibility study being performed for the Boardman River Dams Committee (BRDC) to evaluate a full range of alternatives for the Boardman River considering environmental, economic, engineering, and societal impacts.

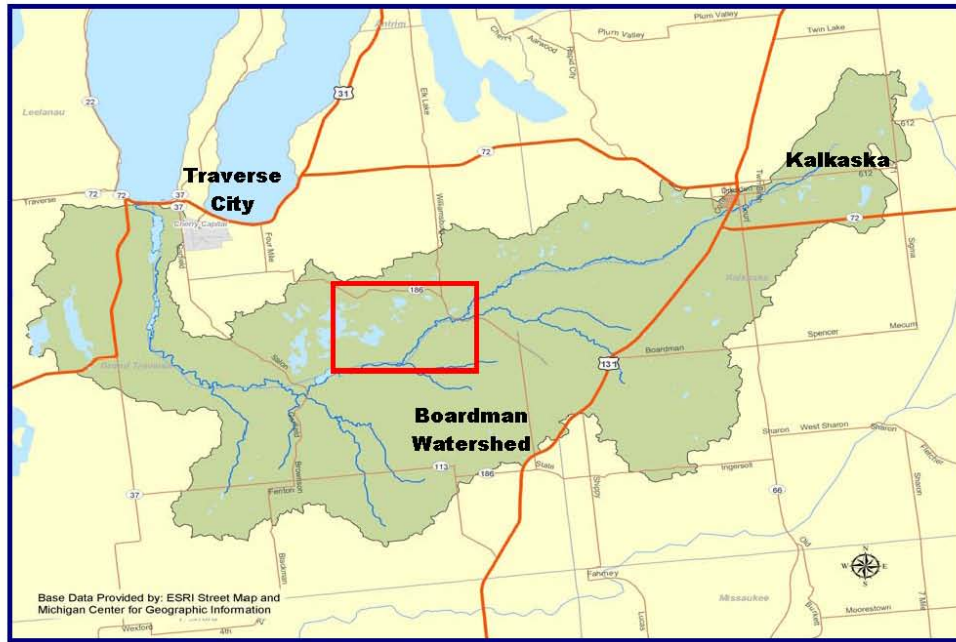
Figure 2

Segment 8:

From the confluence of the North and South Branches of the Boardman River, also known as the Forks, downstream to the Brown Bridge Impoundment

This river segment starts at the confluence of the North and South Branches of the Boardman River (N44°40.487', W85°23.741') (Figure 2). The survey of fisheries habitat began approximately 535 m. downstream at the "Forks" canoe launch (N44°40.403', W85°24.091'), on Brown Bridge Rd, just west of County Rd. 605. This river segment ends downstream at Brown Bridge Pond. The upstream boundary of the formal reservoir or "pond" is at (N44°39.010', W85°29.411'), but impoundment effects were observed upstream an additional 2012 meters upstream to (N44°38.991', W85°28.465'). This will serve as the boundary between river segments 8 and 7, and is predicted to be the upstream extent of the impoundment caused by Brown Bridge Dam. Total length of river in this segment is 10,721 m. The condition of fisheries habitat in this river segment is important to the Boardman River Dams project, because it serves as the best available reference for what habitat conditions in the mainstem Boardman River would be, if not for the presence of the dams.

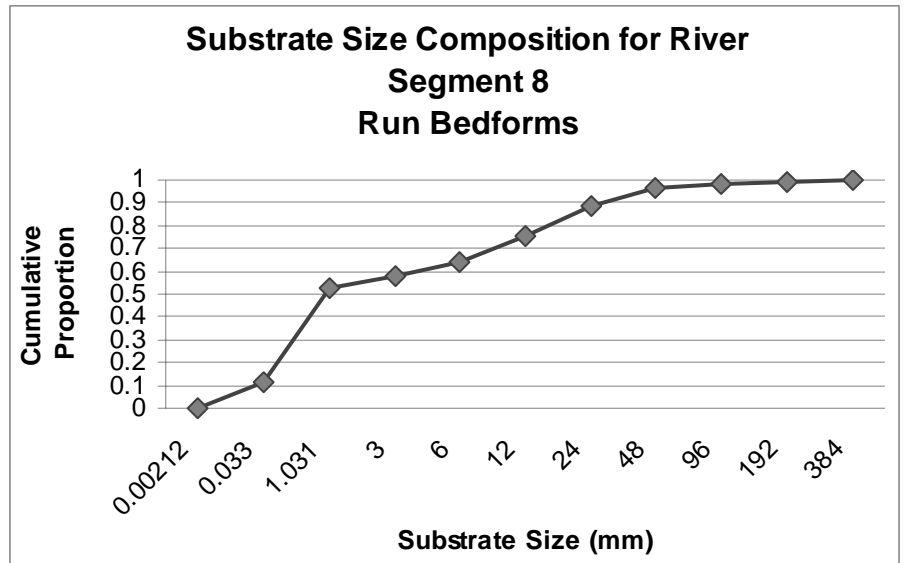
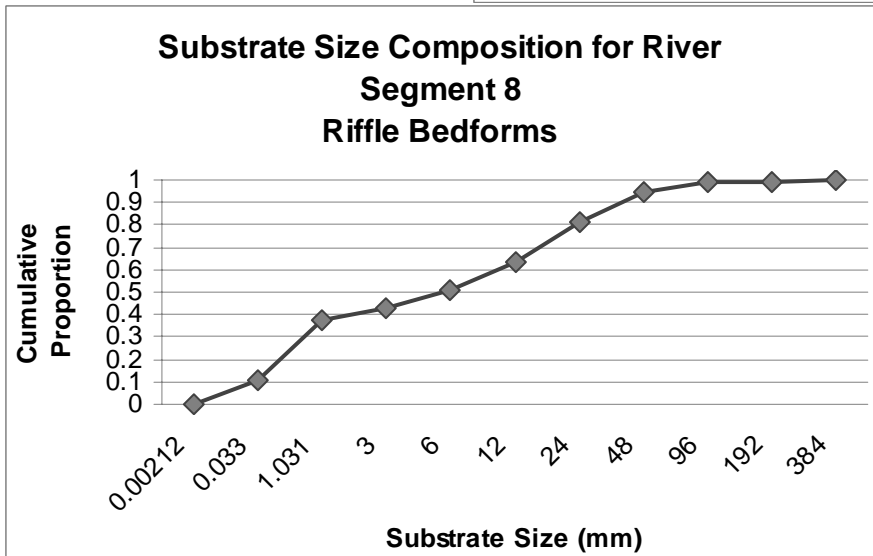
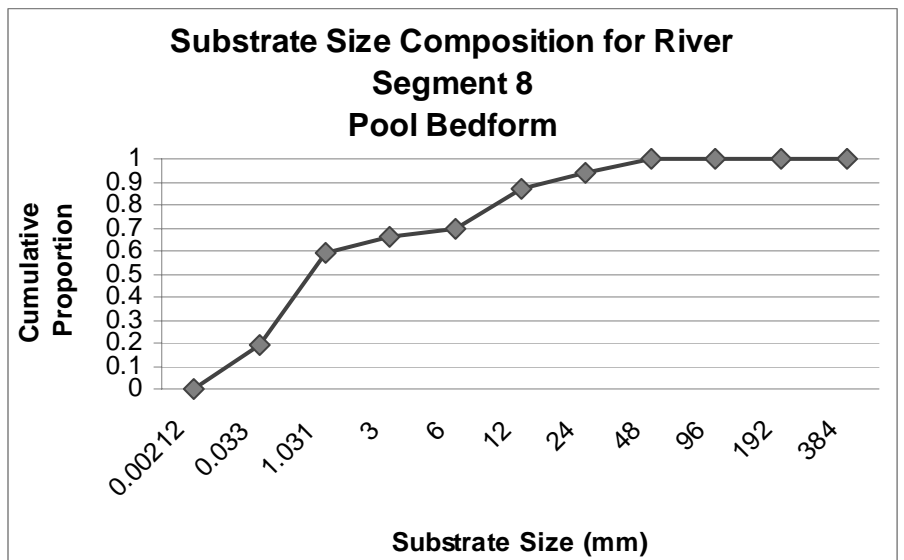
Figure 3. Streambed substrate size cumulative frequency distributions, for river segment 8.

Quantitative measurements of streambed substrate composition were taken at 4 run bedforms, 5 riffles and 1 pool in river segment 8. Median substrate size for run bedforms in segment 8 was sand (1.031 mm), which also comprised 41% of the composition (Figure 3). Runs were comprised of 11% silt, and 48% was gravel, cobble, and boulders. Segment 8 riffle median substrate size was fine gravel (6 mm), and contained 27% sand, 11% silt, and 62% gravel, cobble and boulders (Figure 3). Median substrate size of the pool bedform in segment 8 was sand (1.031 mm), which also comprised 40% of the composition (Figure 3). The pool bedform was also comprised of 19% silt, and 41% was gravel, with no cobble or boulders.

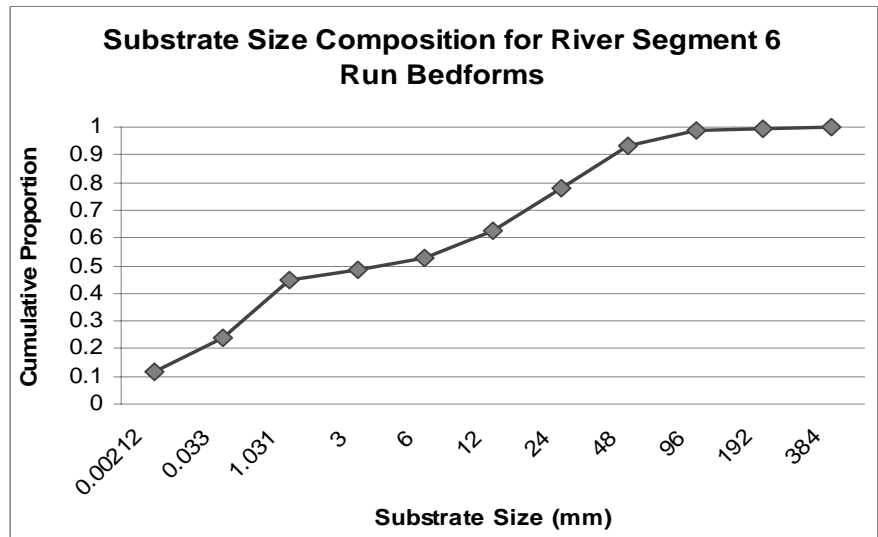
Figure 5. Streambed substrate size cumulative frequency distributions, for river segment 6.

Quantitative measurements of streambed substrate composition were taken at 6 run bedforms, 4 riffles and 2 pools in river segment 6. Median substrate size for run bedforms in segment 6 was fine gravel (6 mm) (Figure 5). Runs were comprised of 12% silt, 21% sand and 55% was gravel, cobble, and boulders, with a well-mixed composition of substrates. Segment 6 riffle median substrate size was medium gravel (12 mm), and contained 8% silt, 23% sand and 69% gravel, cobble and boulders (Figure 5). Median substrate size the pool bedforms in segment 6 was very fine gravel (3 mm)(Figure 5). The pool bedform was also comprised of 6% silt, 42% sand and 52% was gravel, cobble and boulders (Figure 5).

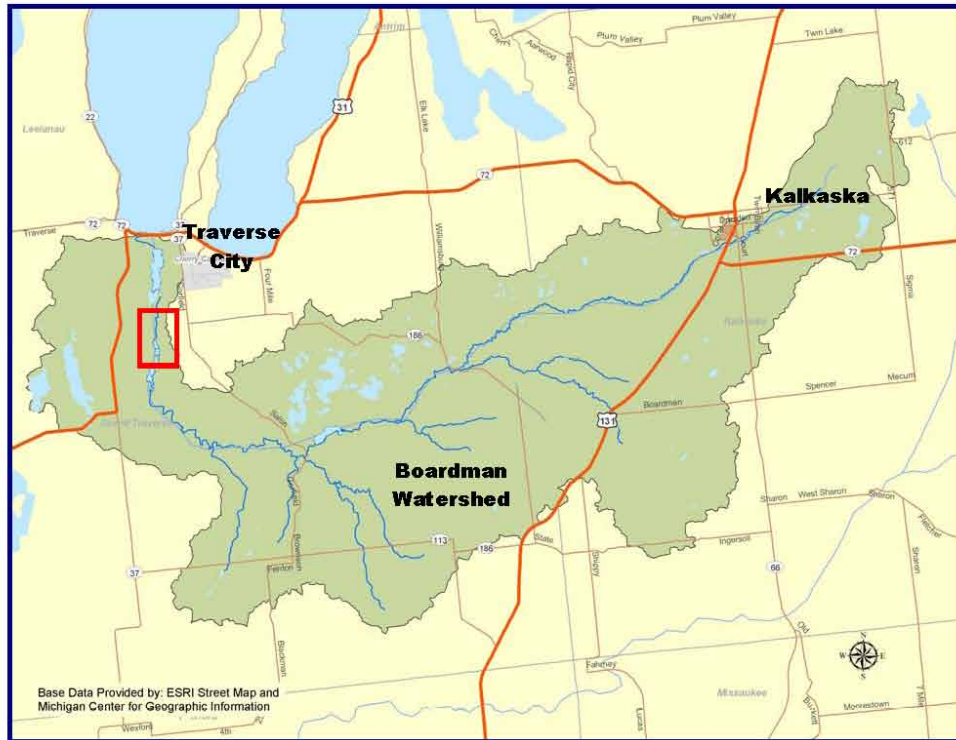
Figure 6

Segment 3:
From Sabin Dam downstream to
Union Street Dam impoundment,
or Boardman Lake

River segment 3 starts at Sabin Dam (N44°42.461', W85°37.374') and extends downstream to Union Street Dam Impoundment (also known as Boardman Lake) (Figure 6). During this survey, impacts on fisheries habitat due to Sabin Dam were observed for a distance approximately 860 m downstream of Sabin Dam (Appendix C). At this point, impoundment effects on fisheries habitat were evident from the Union Street Dam. This entire river segment is therefore determined to be impacted by Boardman River dams. This survey proceeded from Sabin Dam downstream to Airport Rd (N44°44.016', W85°36.986'), a distance of 3540 m.

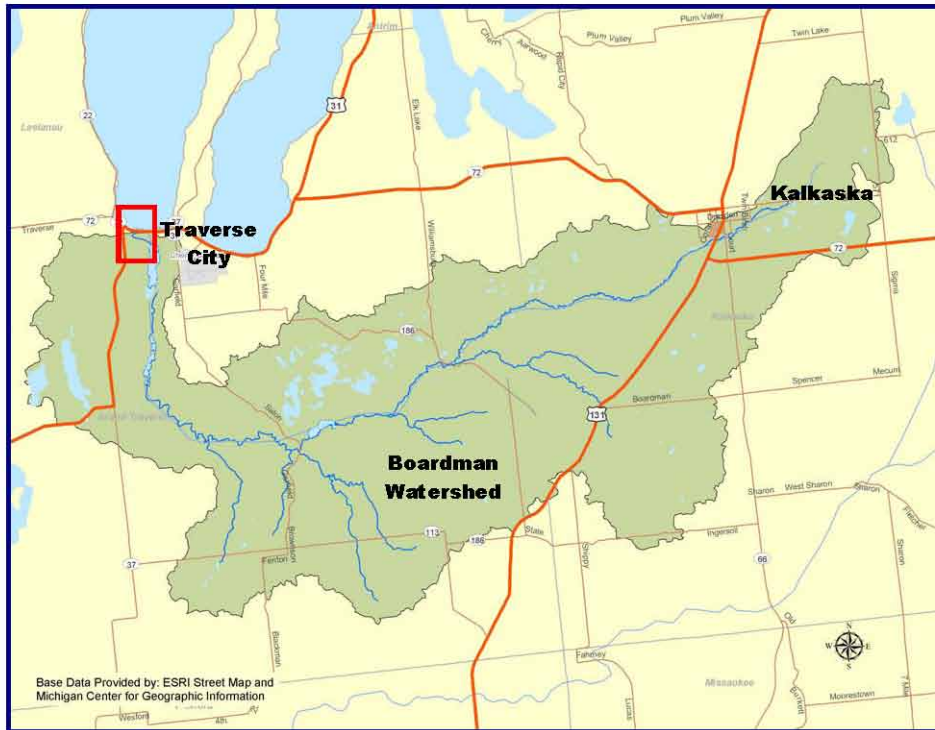
Figure 7

Segment 1:
From Union Street Dam
downstream to Lake Michigan
and Hospital (Kids) Creek

This river segment starts at Union Street Dam (N44°45.707', W85°37.391') and extends downstream to the river's confluence with the waters of Lake Michigan (N44°45.925', W85°36.860') (Figure 7). Fisheries habitat was surveyed from Union Street Dam downstream to the M31 highway bridge (N44°45.889', W85°36.875'), a distance of 1865 m. There is also a fish migration weir in this river segment, located at (N44°45.876', W85°37.592'). This river segment flows through downtown Traverse City, and is channelized along its entire course. The impeded sediment transport due to Union Street Dam, the channelized stream channel, and the impoundment effects from Lake Michigan have impacted this entire river segment.
