BOARDMAN RIVER FEASIBILITY STUDY

Preliminary Engineering Evaluation of Existing Structures

January 2008

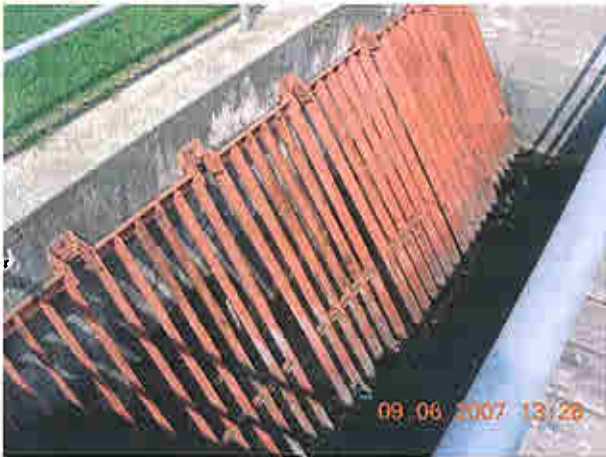
Trash rack on upstream side of inlet section of auxiliary spillway

- Repair and realign trash racks in Bay #2 of the principal spillway
- Continue weekly maintenance inspections and good maintenance practices.
- Lubricate and exercise all principal spillway gate operator stems on an annual basis.
- The Emergency Action Plan (EAP) should be reviewed and updated on an annual basis. A copy of the updated EAP should be provided to the MDEQ Dam Safety Program when significant changes to the EAP occur.

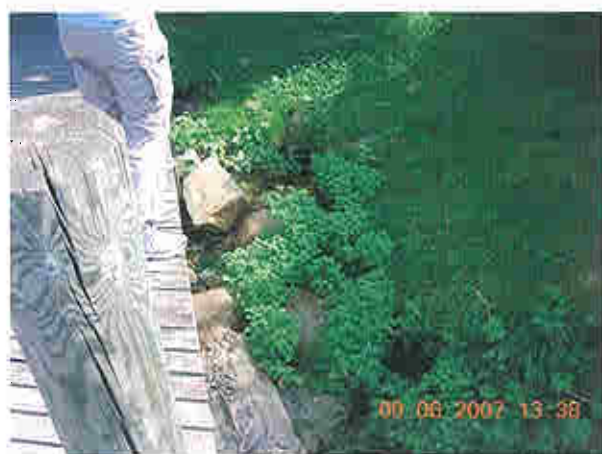
Riprap and seepage at left embankment of principal spillway

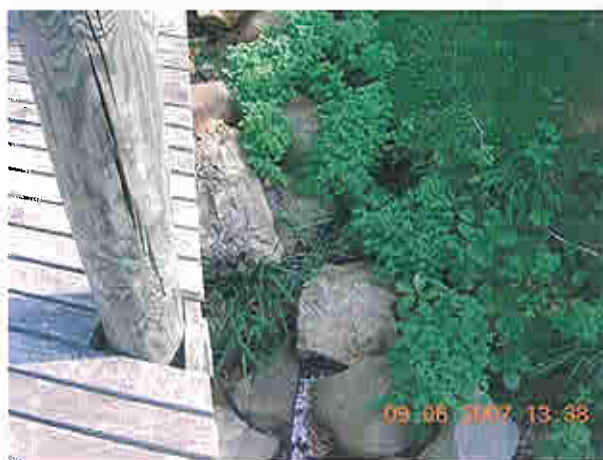
Riprap and seepage at left embankment of principal spillway

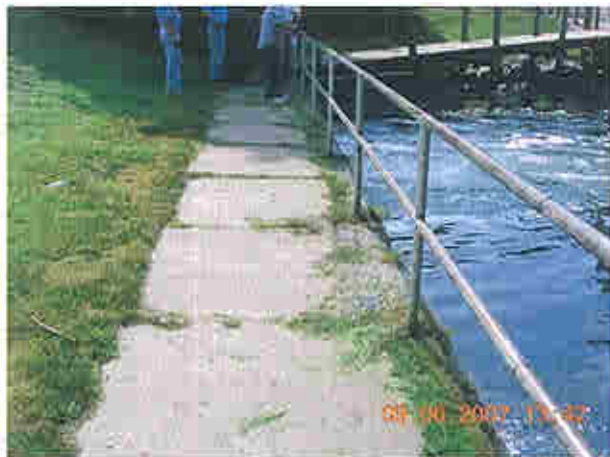
Sidewalk adjacent to downstream side of principal spillway
Note seepage at edge of sidewalk

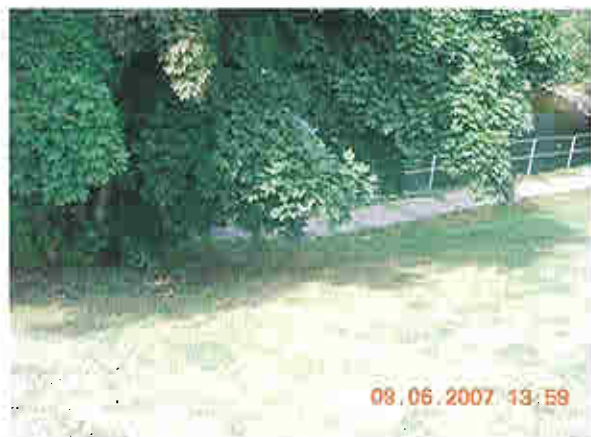
Downstream slope at principal spillway, left end, note large tree

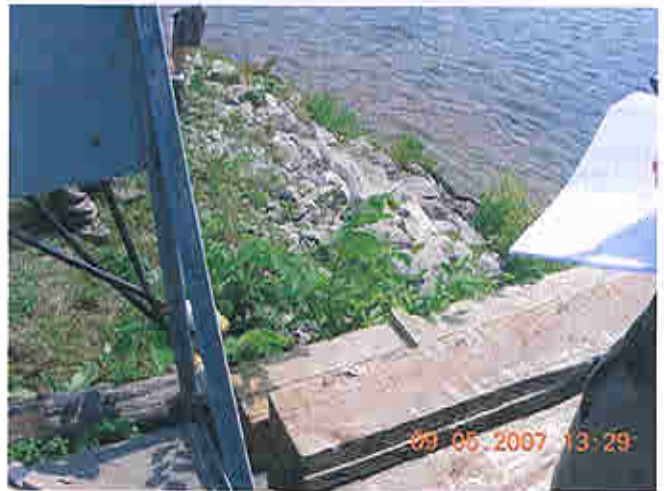
Upstream shoreline of the intermediate embankment- note rip rap placed to control erosion.

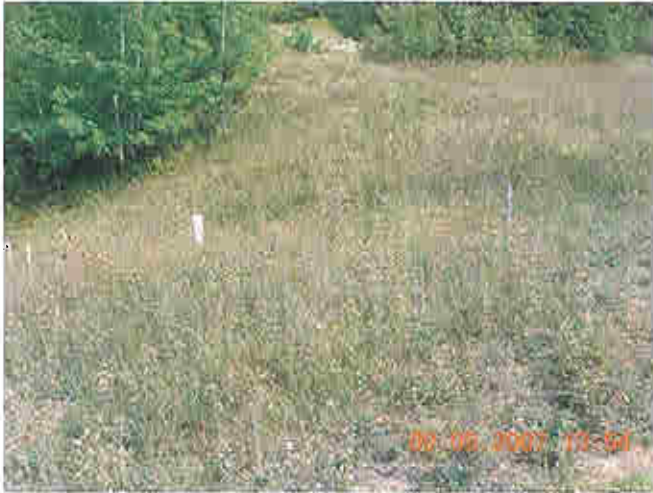
Downstream slope of right embankment- note, piezometers
(County continues to monitor piezometers)

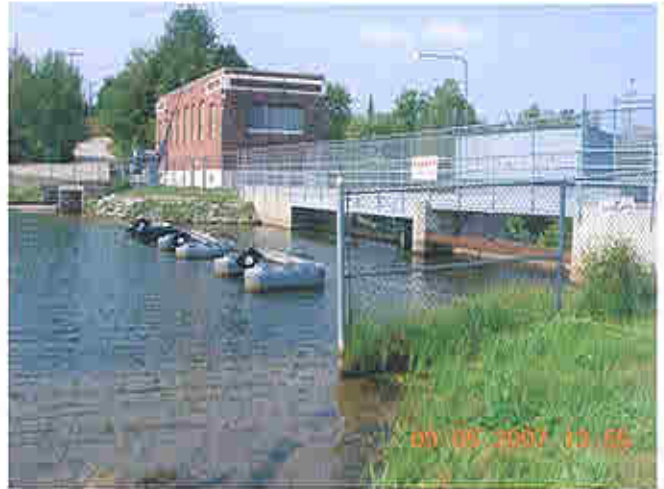
Upstream side of dam, view from right embankment

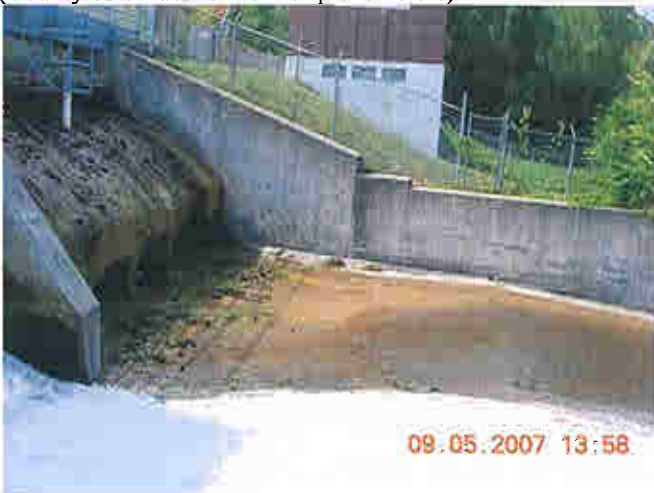
Downstream side of stop log spillway

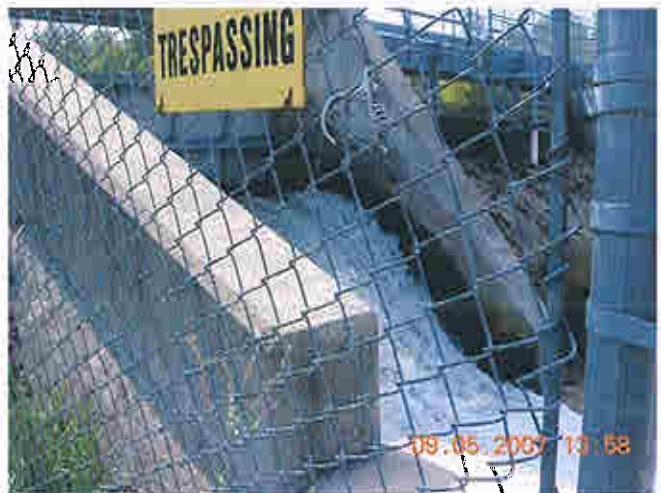
Downstream side of tainter gate spillway

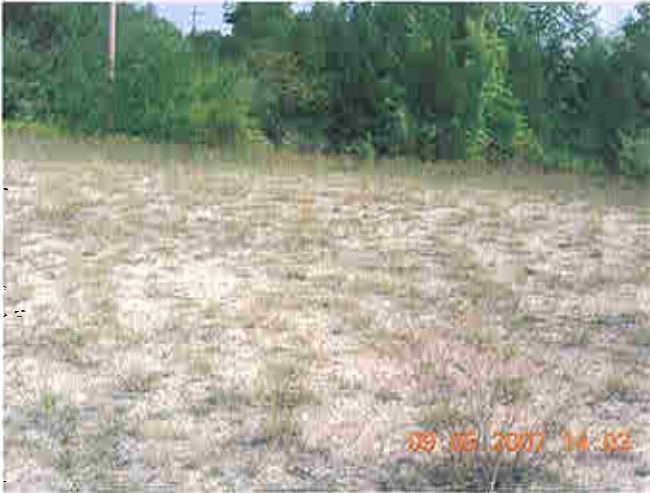
Downstream of right embankment, unvegetated sandy area

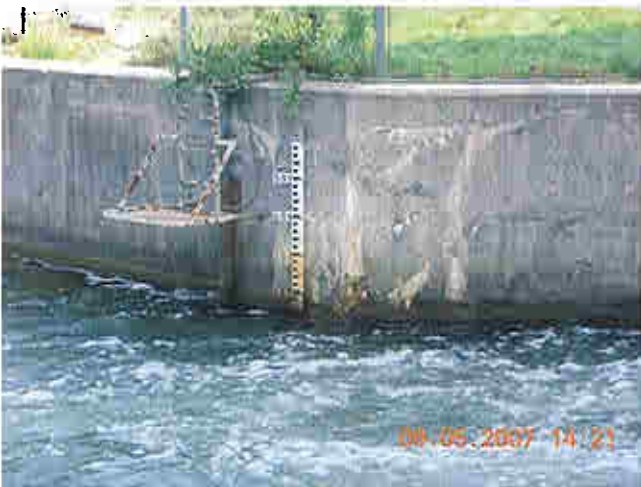
Tail water staff gauge downstream of power house
(County reads head and tail water elevations each day)

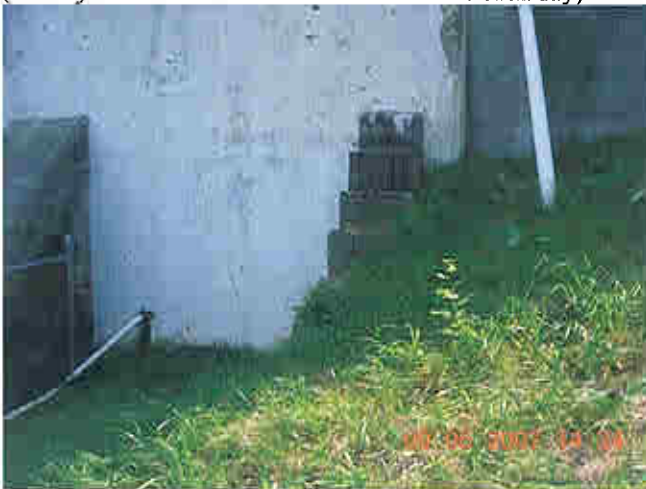
Area of seepage at powerhouse at left embankment

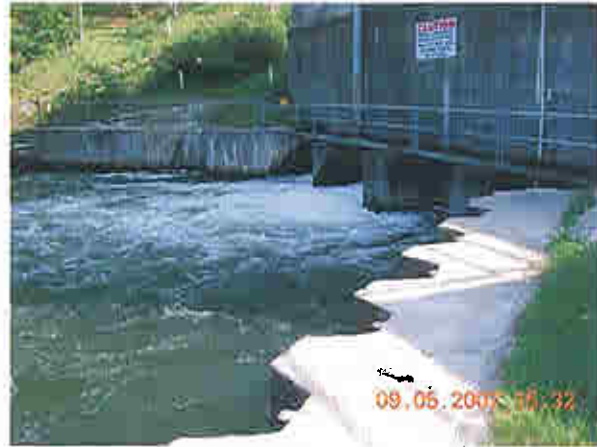
Downstream side of powerhouse

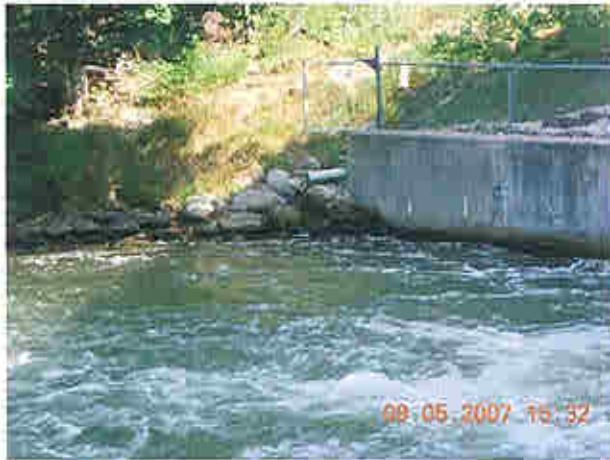
Right downstream abutment of powerhouse, note water flowing

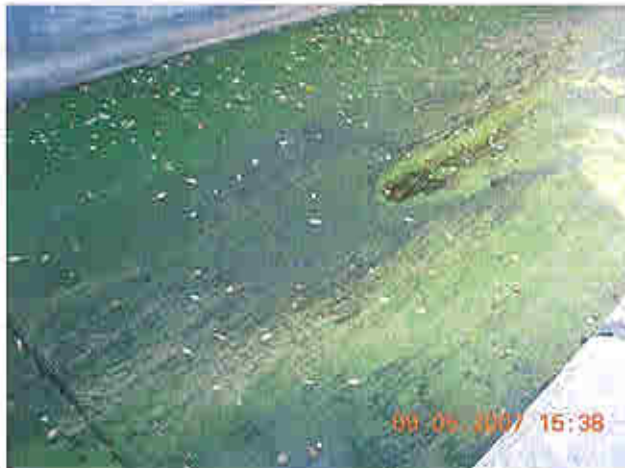
Downstream of spillway, note seeps in bottom of channel

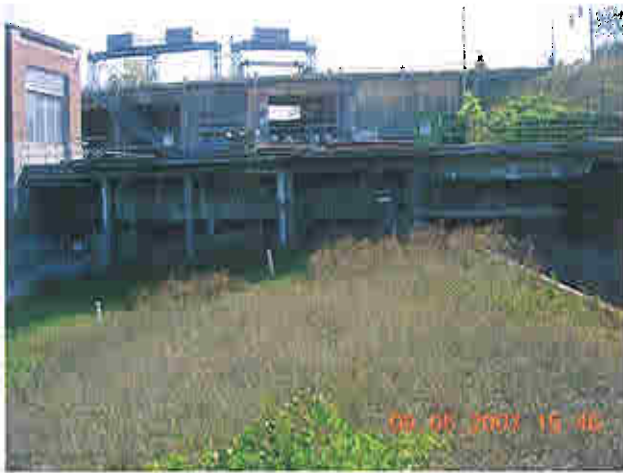
Downstream side of access deck

Aside from the cost estimates, we recommend that a structural evaluation be conducted at Boardman Dam. As indicated in this report, there is particular concern for the Cass Road Bridge and the access deck. We would then recommend that any concerns or issues that arise as a result of this evaluation be addressed as necessary.

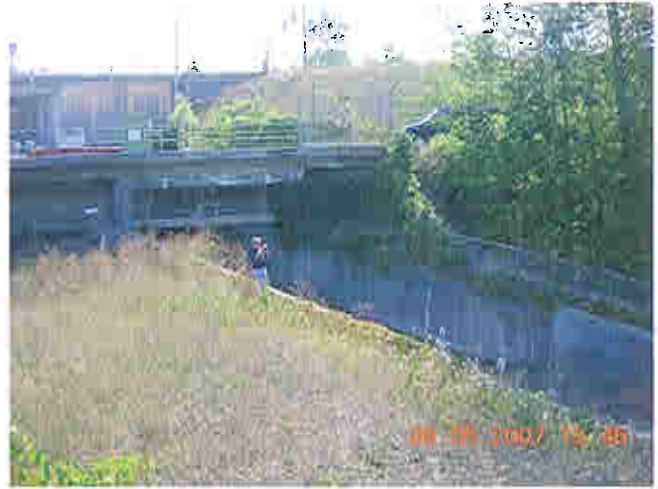
Downstream side of access deck

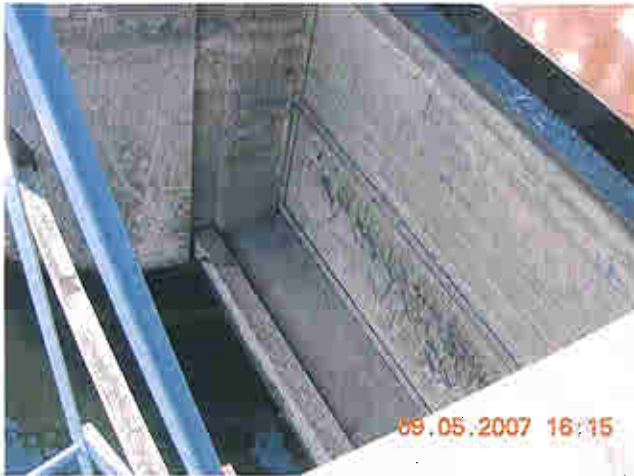
Gate at spillway

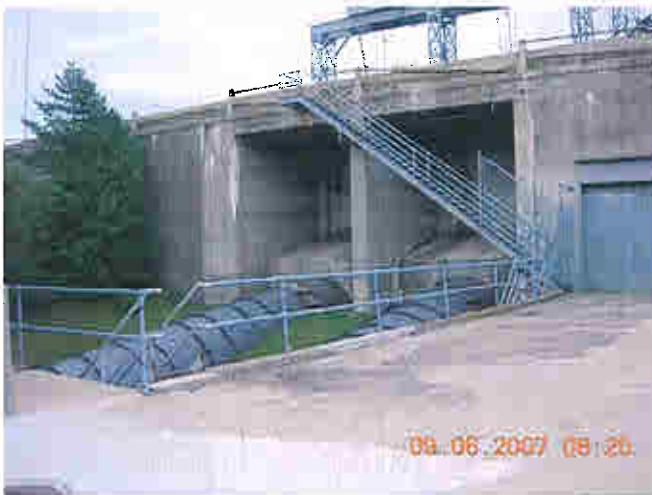
Downstream side of road, note penstocks

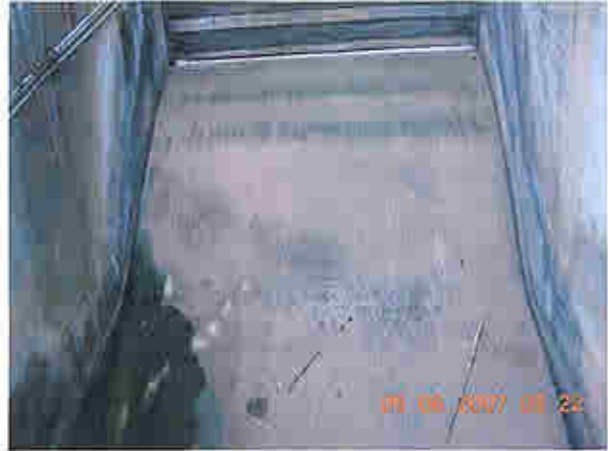
Downstream side of spillway, note seepage

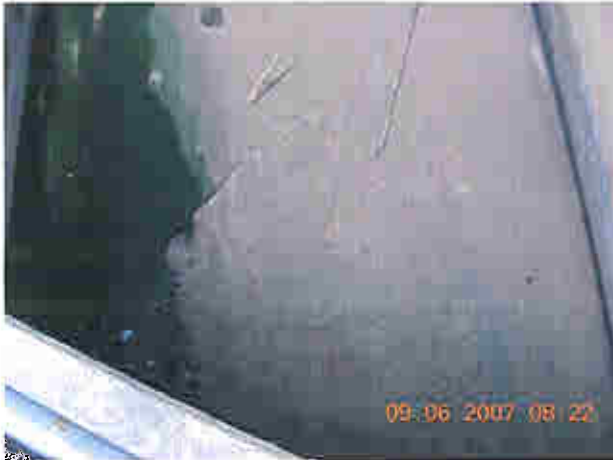
Downstream side of spillway, note seepage

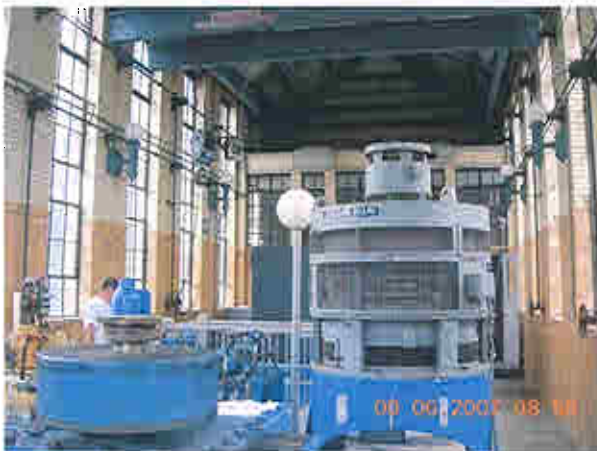
Interior of powerhouse

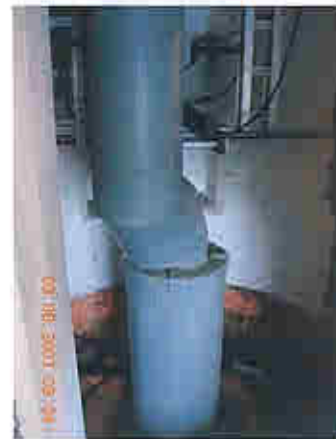
Power generation equipment

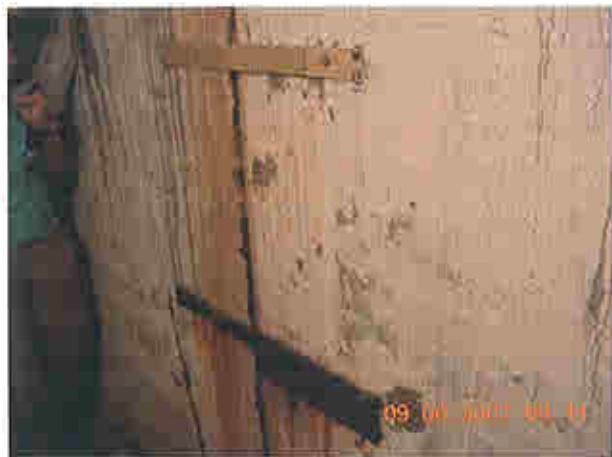
Crack monitors in lower level of powerhouse

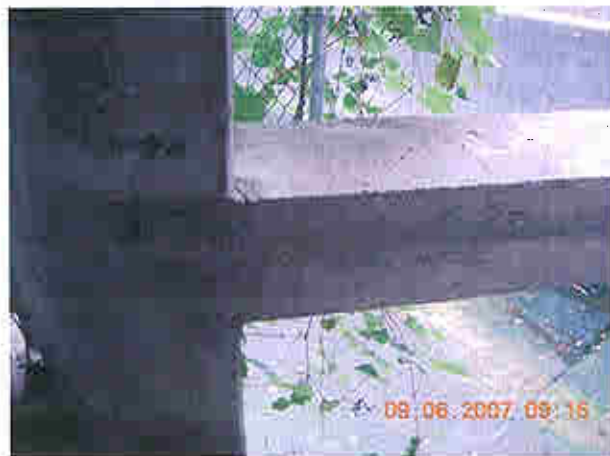
Supports for access deck

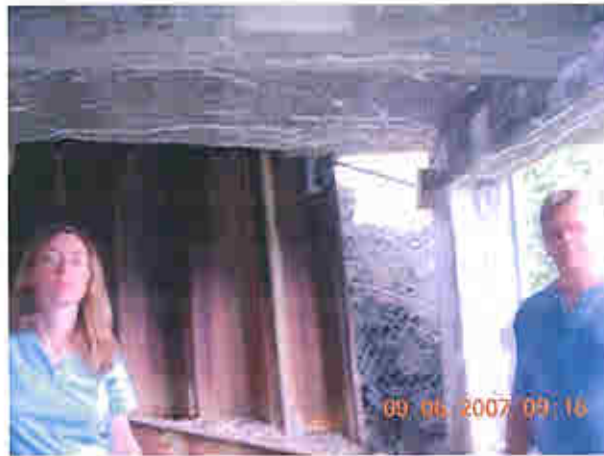
Underneath of access deck, downstream of powerhouse

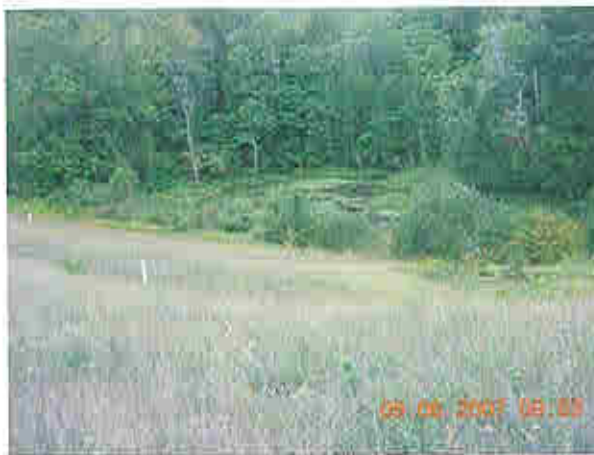
Detached earth embankment, downstream slope, note standing water at toe of slope

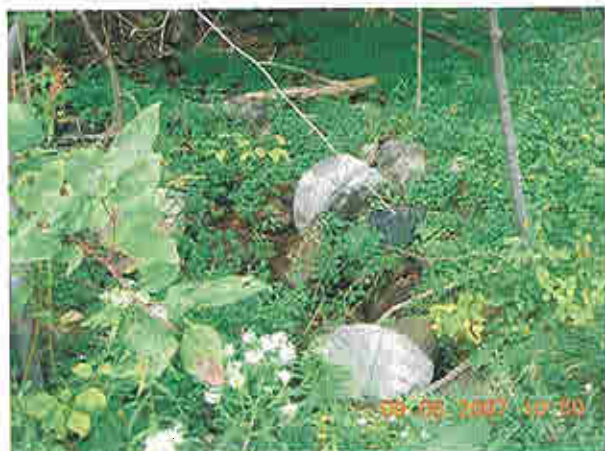
Seepage at left end of detached earth embankment

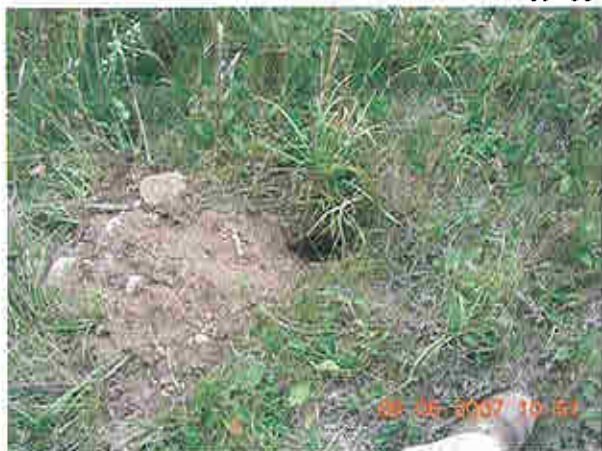
Rodent hole on downstream slope of detached embankment

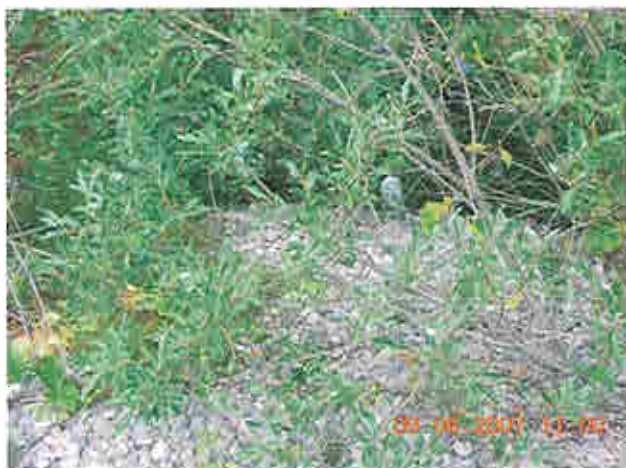
Downstream of detached embankment, note stone and pipe

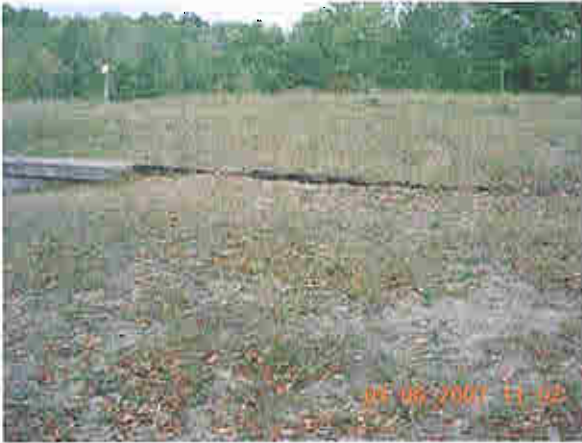
Sheet pile extending at right side of concrete wall at detached embankment

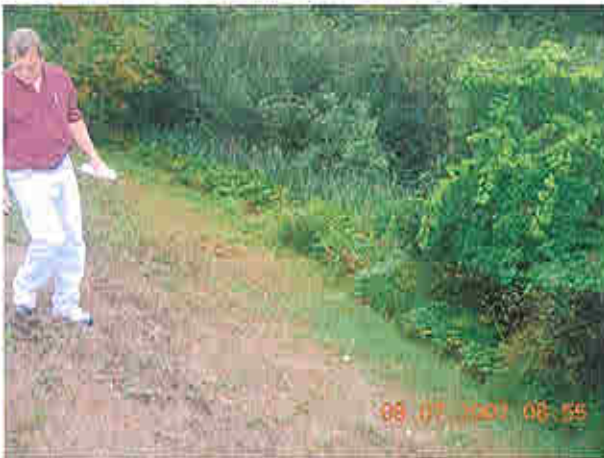
Downstream slope of left embankment at left end, note wet toe

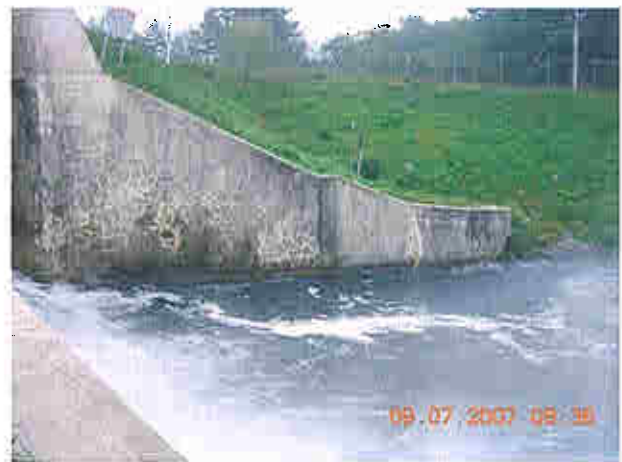
Left downstream abutment and embankment

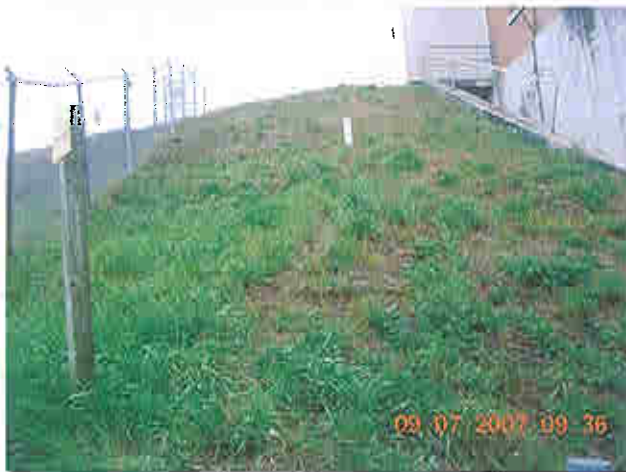
Downstream right embankment slope

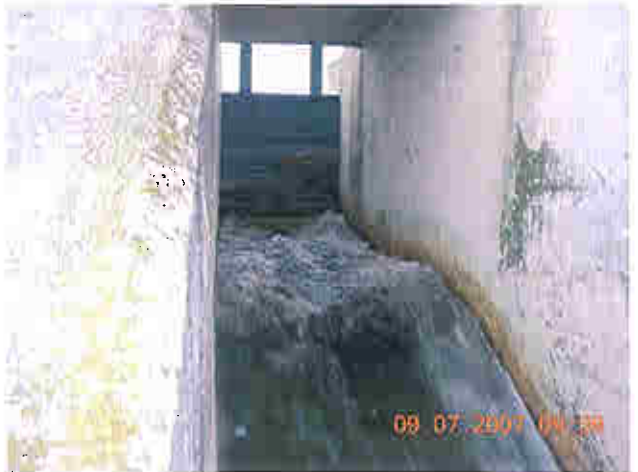
Downstream side of gate at log chute spillway

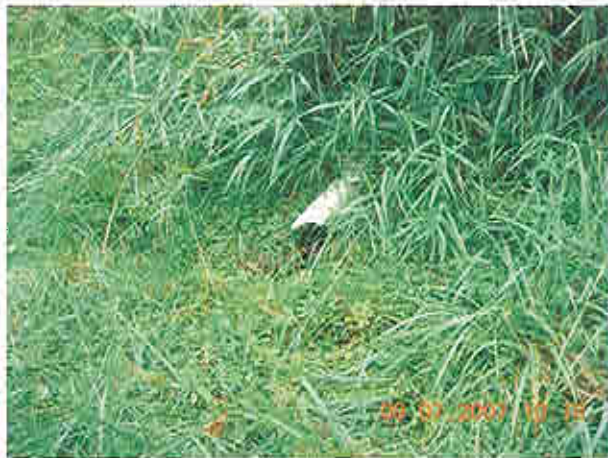
Pipe at downstream slope of right embankment

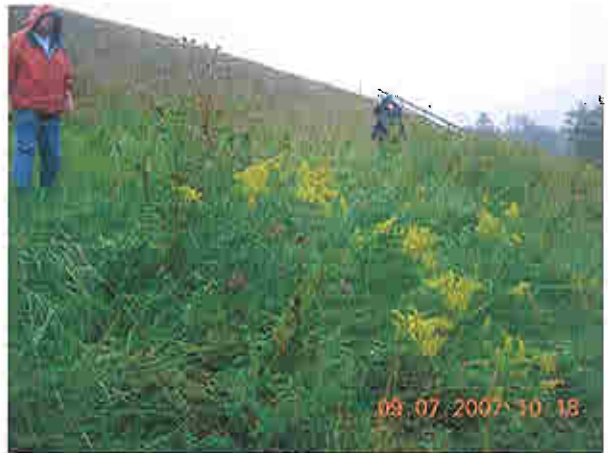
Downstream slope of right embankment, note heavy vegetation near bottom quarter of slope

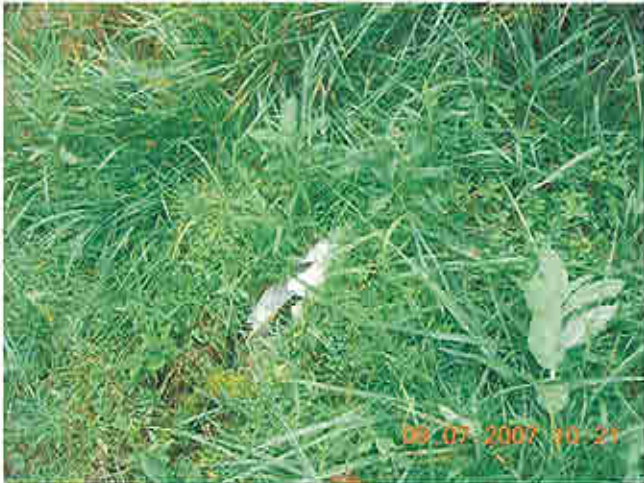
Pipe with flowing water and sedimentation, downstream slope of right embankment

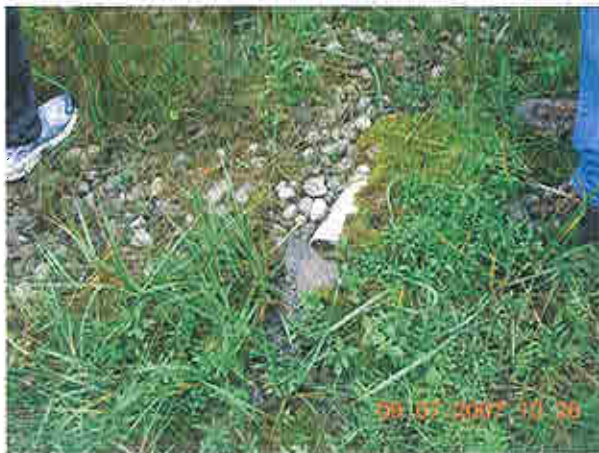
Pipe with flowing water and sedimentation, downstream slope right embankment

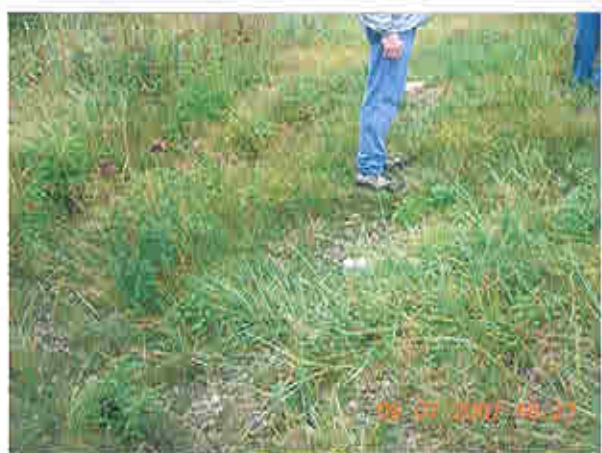
Downstream slope of right embankment

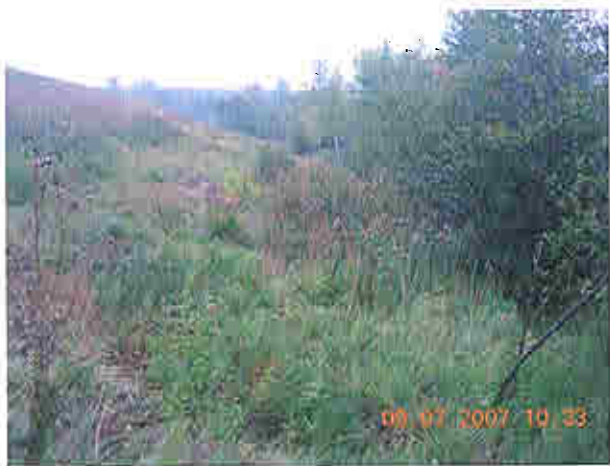
Downstream slope of right embankment

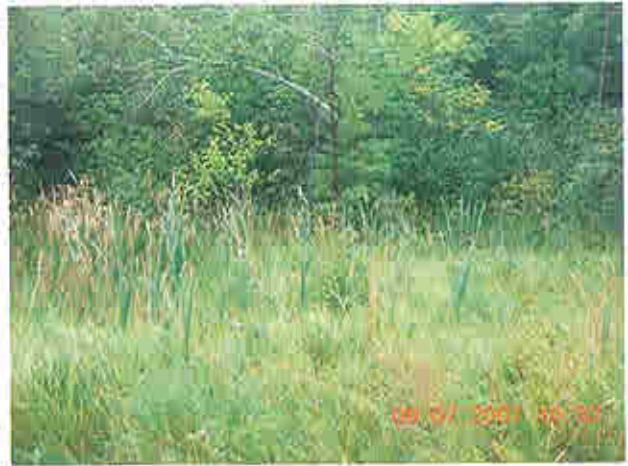
Downstream of downstream slope of right embankment

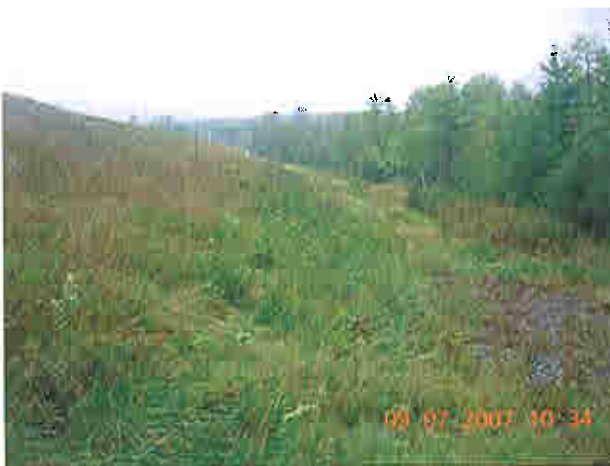
Downstream slope of right embankment

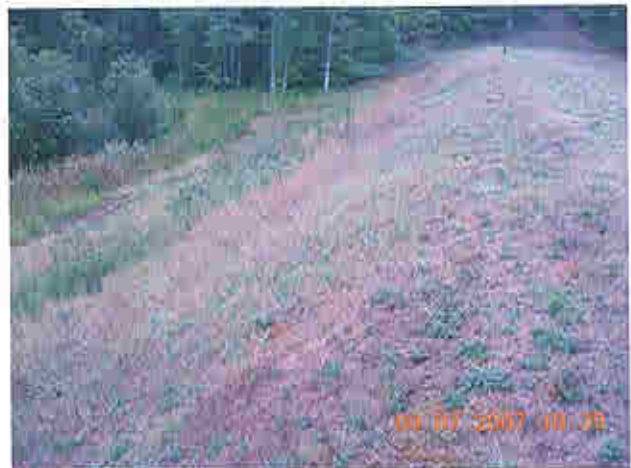
Downstream slope of right embankment

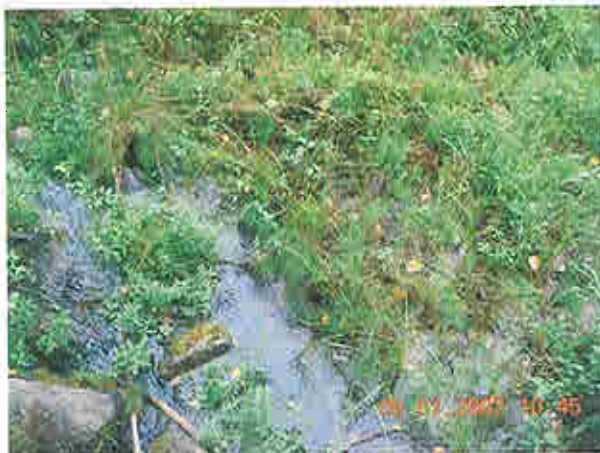
Downstream slope of right embankment

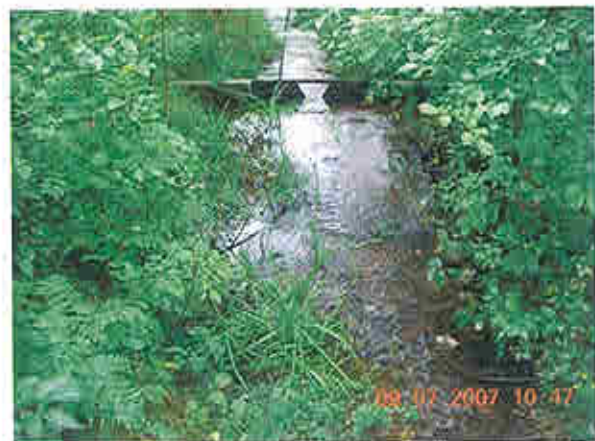
Monitoring weir downstream of downstream slope of right embankment- assumed to measure seepage flow

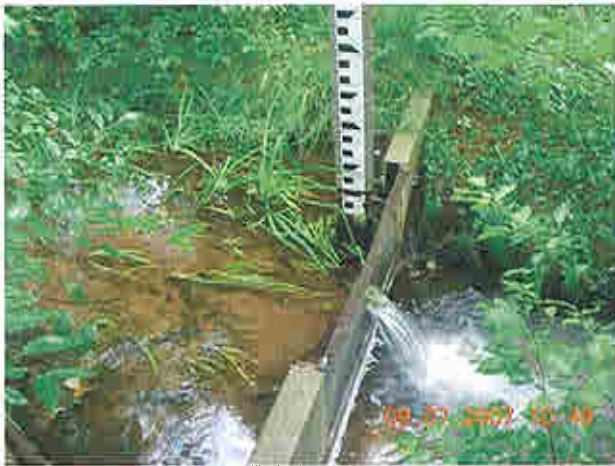
Monitoring weir downstream of downstream slope of right embankment- assumed to measure seepage flow

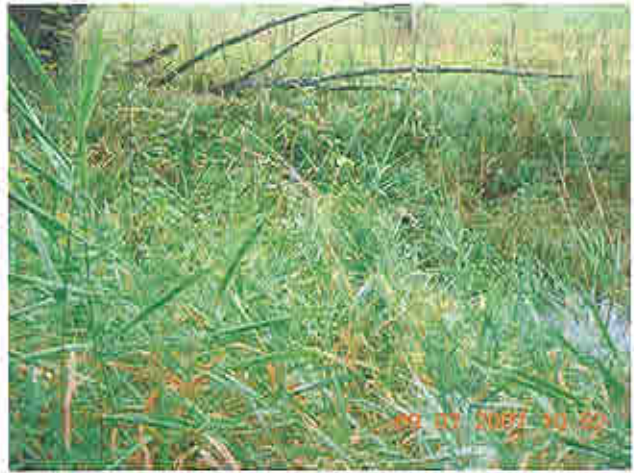
Stream downstream of downstream slope of right embankment assumed to originate from seepage at slope

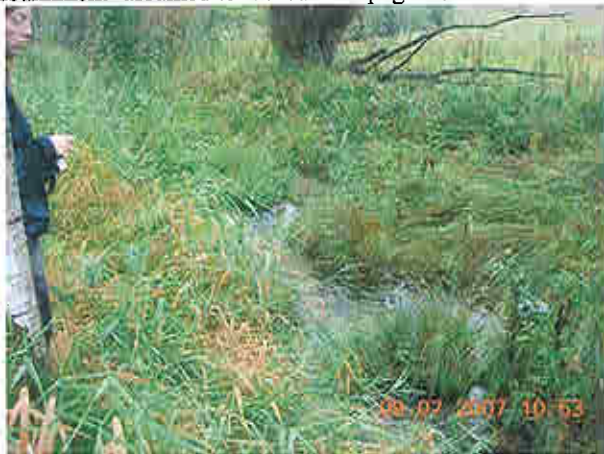
Stream downstream of downstream slope of right embankment

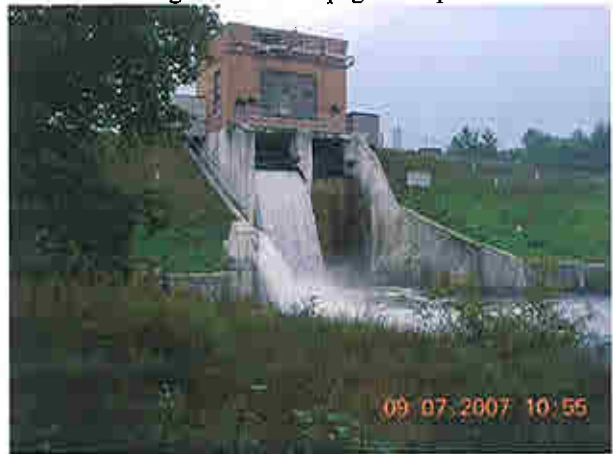
Downstream side of dam

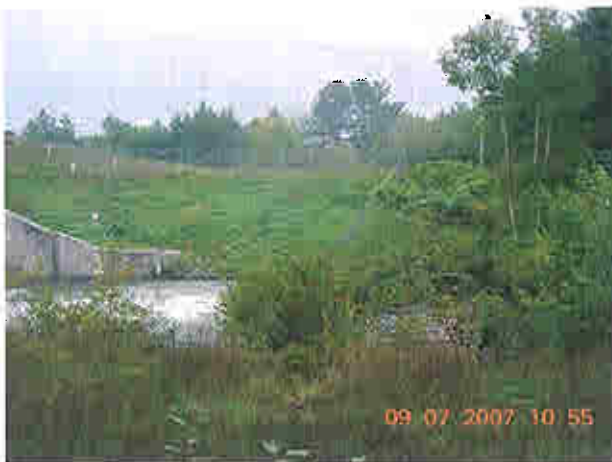
View of left embankment

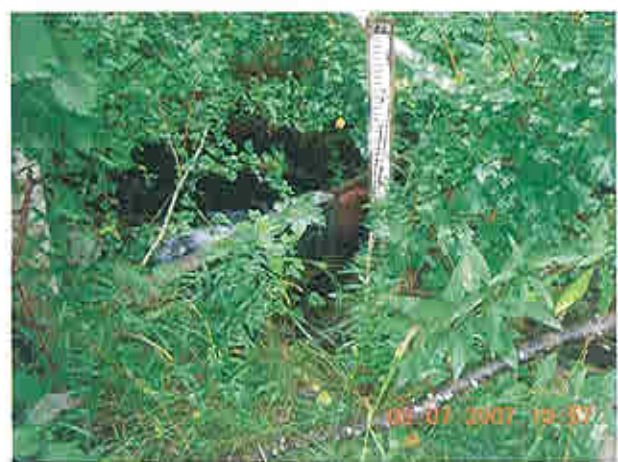
Measurement weir- assumed to measure seepage and natural stream flow

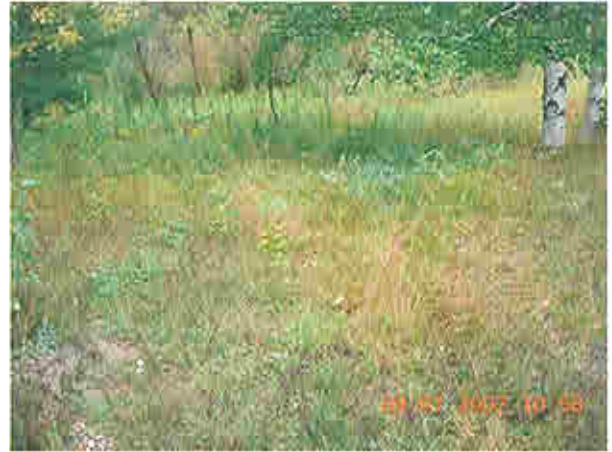
Area downstream of downstream slope of right embankment

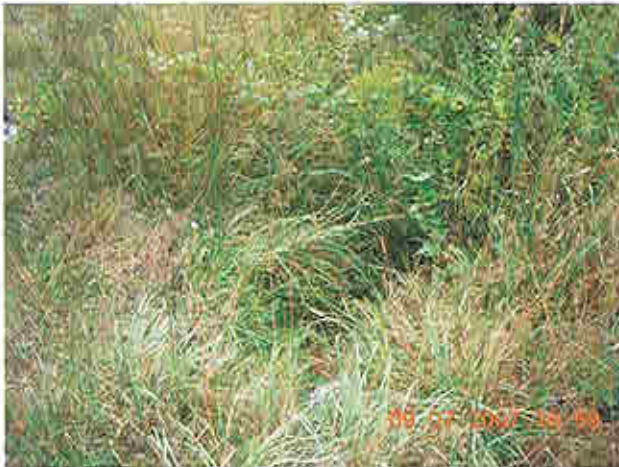
Seepage downstream of downstream slope of right embankment

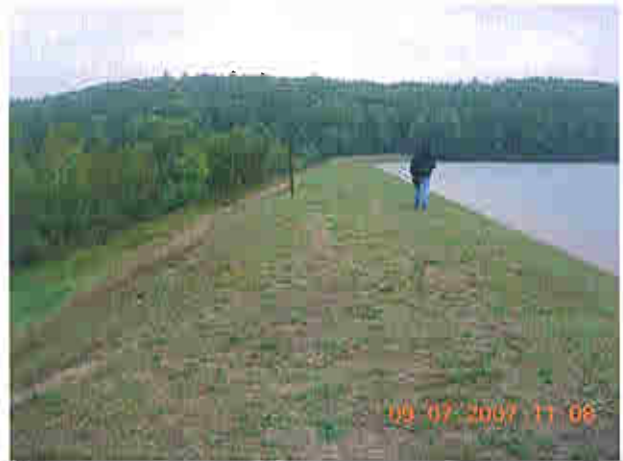
Right embankment, view looking right

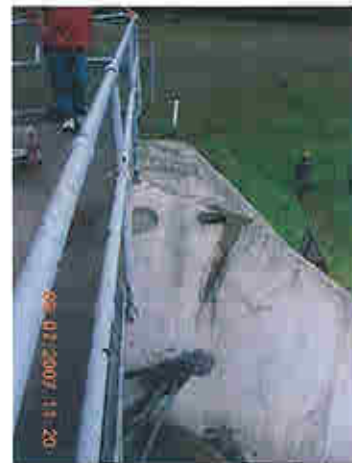
Right face of left wall of right tainter gate spillway

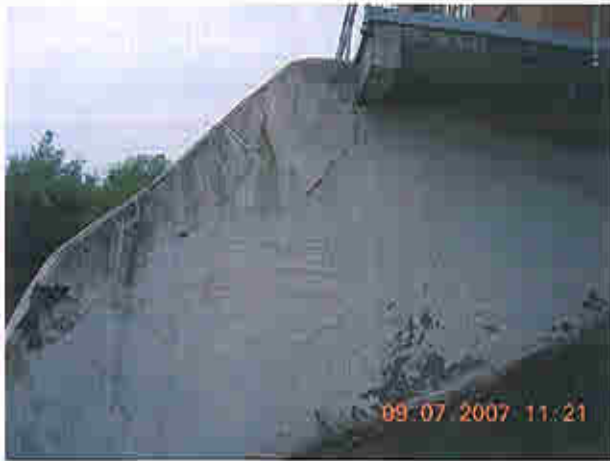
Left face of left wall of right tainter gate spillway

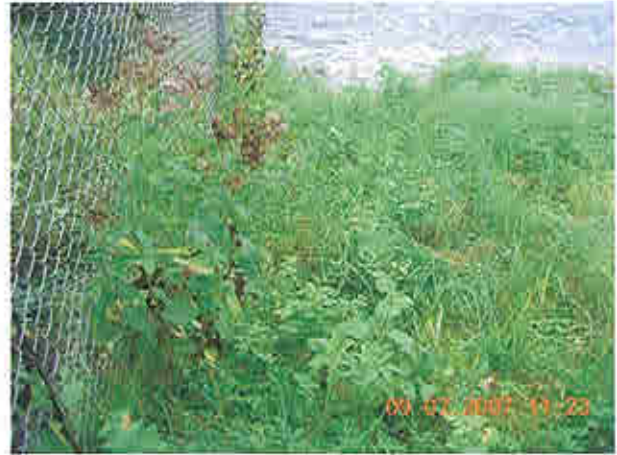
Downstream slope of left embankment, note heavy vegetation

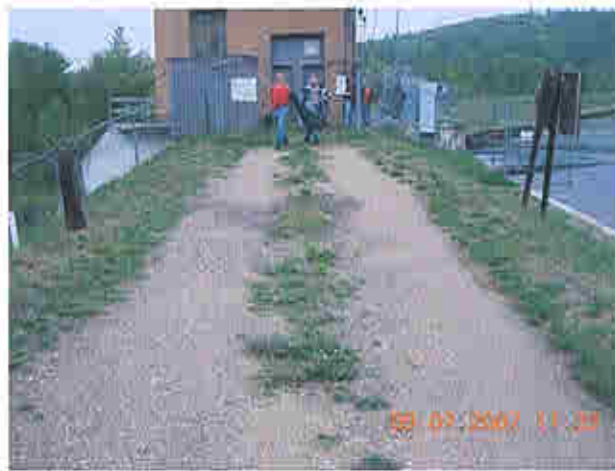
Roadway just left of powerhouse, view looking right
Note low area in roadway
