Safety Inspection of Brown Bridge Dam

**The City of Traverse
City Engineering Office
400 Boardman Avenue, 2nd Floor
Traverse City, Michigan 49684**

**STS Project No. 200802039
September 17, 2008**

**Prepared by:
STS
Michael D. Carpenter, P.E.
Senior Project Engineer
(906) 226-4963**

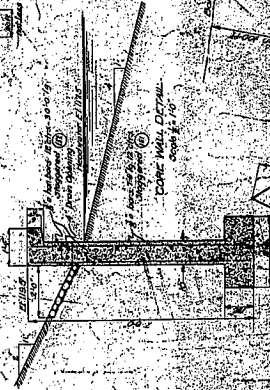
TYPICAL SECTION THROUGH CONCRETE ENABLING WALL

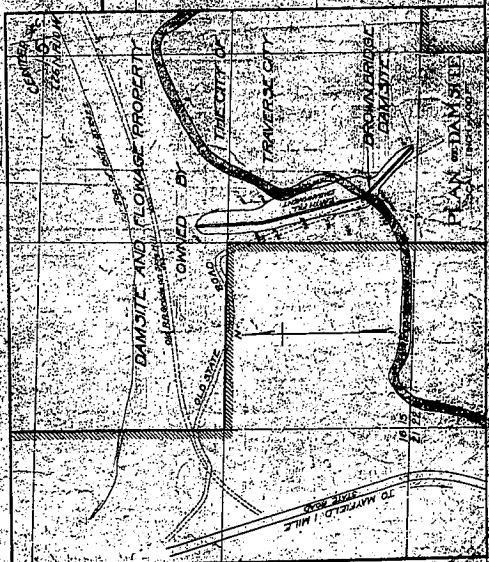
DAM SITE AND FLOWAGE PROPERTY

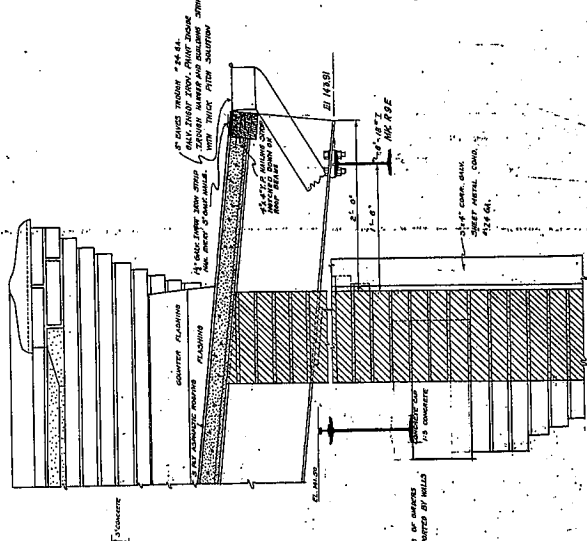
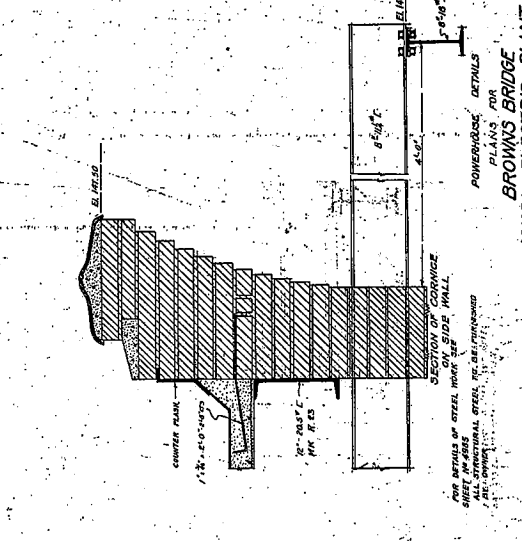
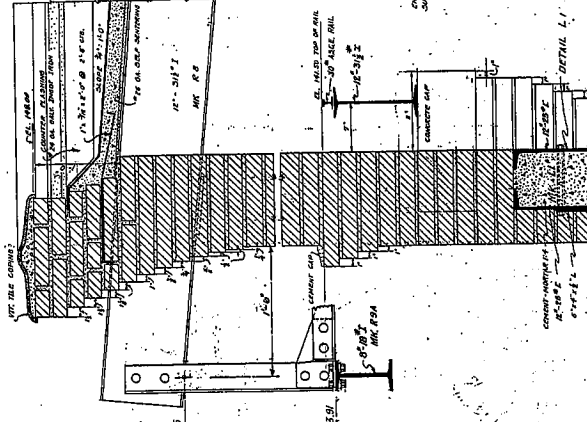
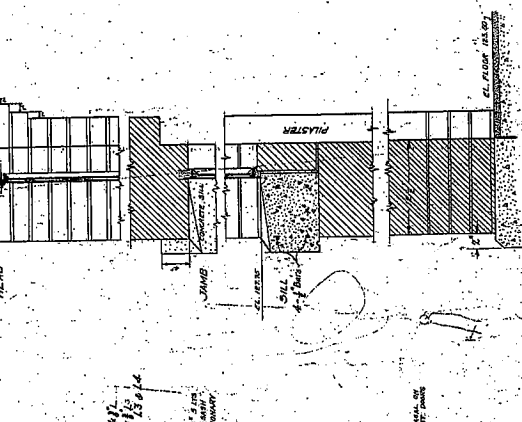
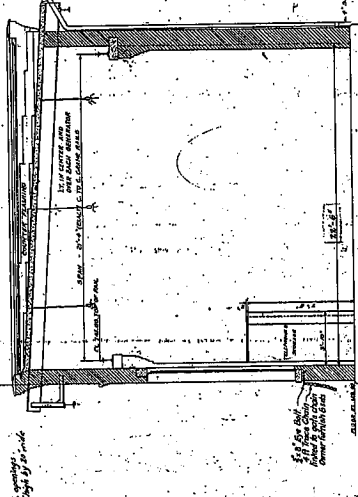
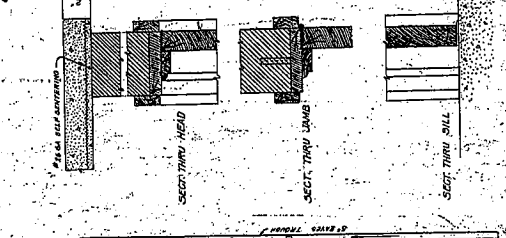
POWERHOUSE DETAILS
SHEET NO. 4984
SCALE: 1/4" = 1'-0"

PLANS FOR
BROWNS BRIDGE
HYDRO-ELECTRIC PLANT
ON THE
BROWNS RIVER
CITY OF TRAVERSE CITY
MICHIGAN

Powerhouse Details (1921)
