BOARDMAN RIVER FEASIBILITY STUDY

Preliminary Engineering Evaluation of Existing Structures

January 2008

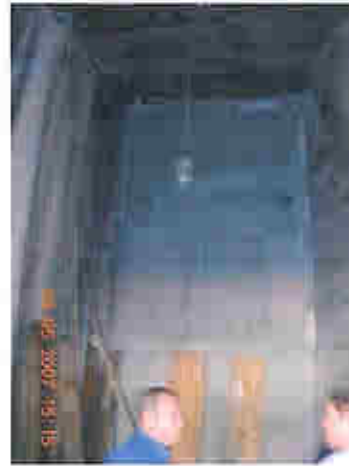
Storage bay

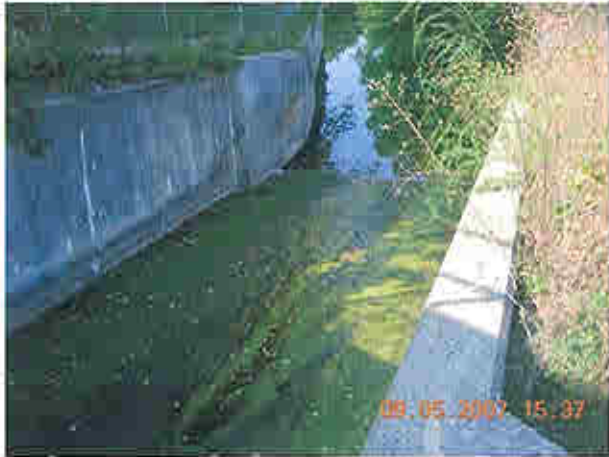
Downstream of spillway, note seeps in bottom of channel

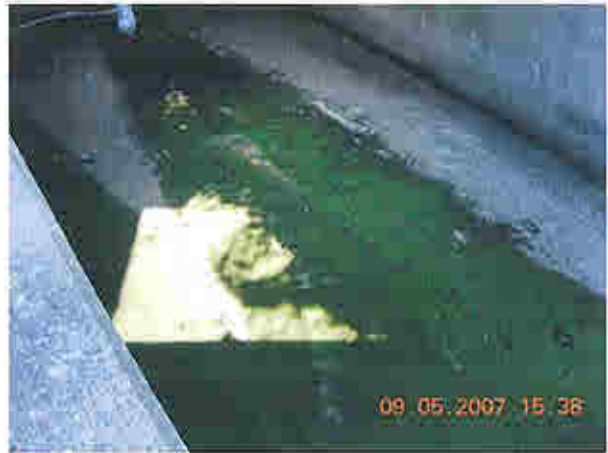
Downstream of spillway, note seeps in bottom of channel

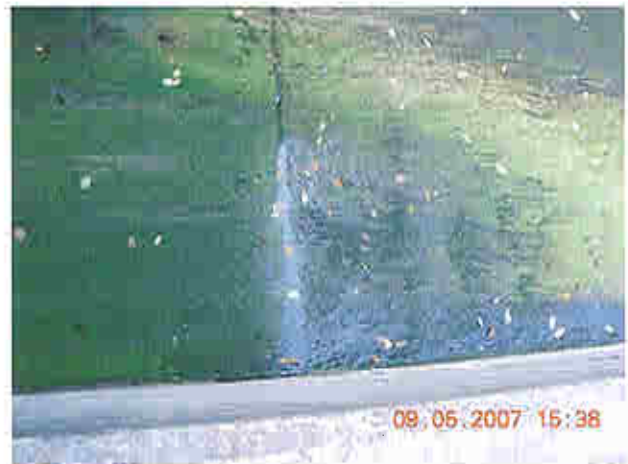
Downstream of spillway, note seeps in bottom of channel

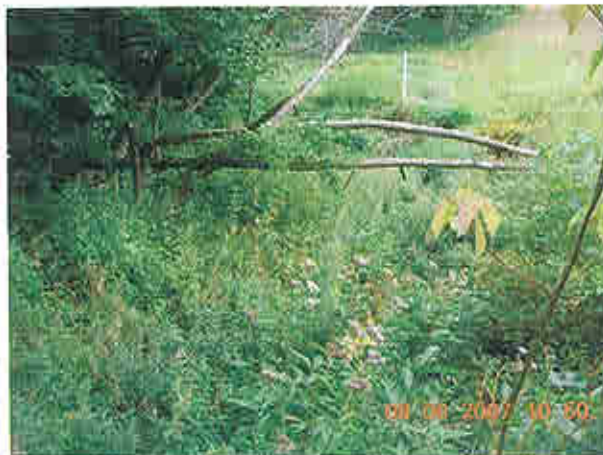
Seepage at left end of detached earth embankment

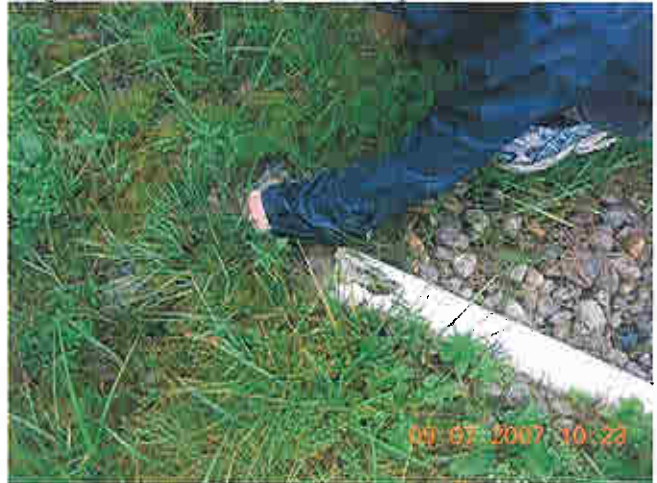
Pipe with flowing water and sedimentation, downstream slope of right embankment

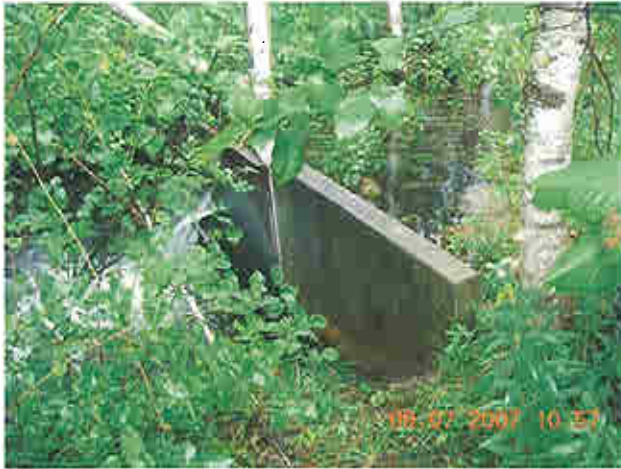
Measurement weir- assumed to measure seepage and natural stream flow

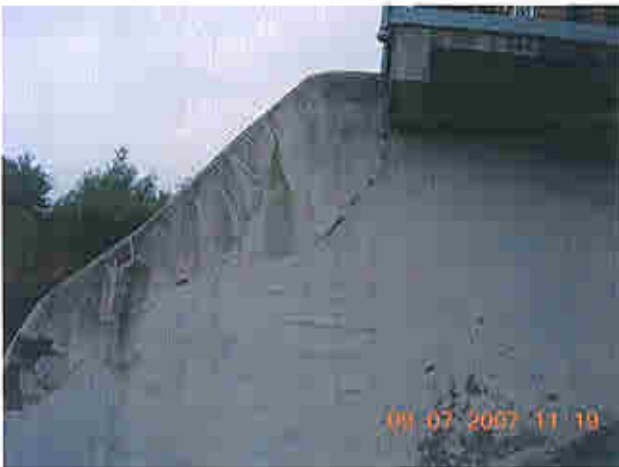
Left face of left wall of right tainter gate spillway
